Work Request Follow-Up Report Vibration Analysis

Area 700 Power Generation G745A Liquid Ring Vac Pump

Pump DE bearing Damage
(Corrosion)

June 2015

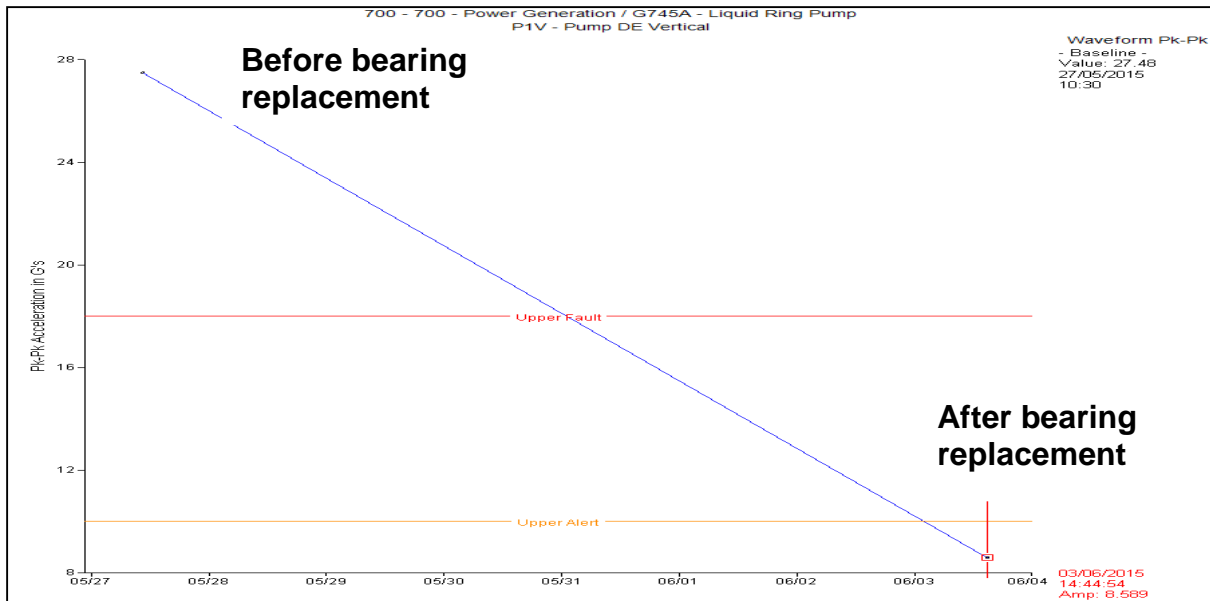
The vibration trend above (Waveform PK-PK G's) shows a clear drop in G levels after the pump bearings were replaced in early June.
