Primary Air Fan COGA Unit

Fault Analysis Report

5031-7010 Primary Air Fan (Fan DE Bearing Problem)

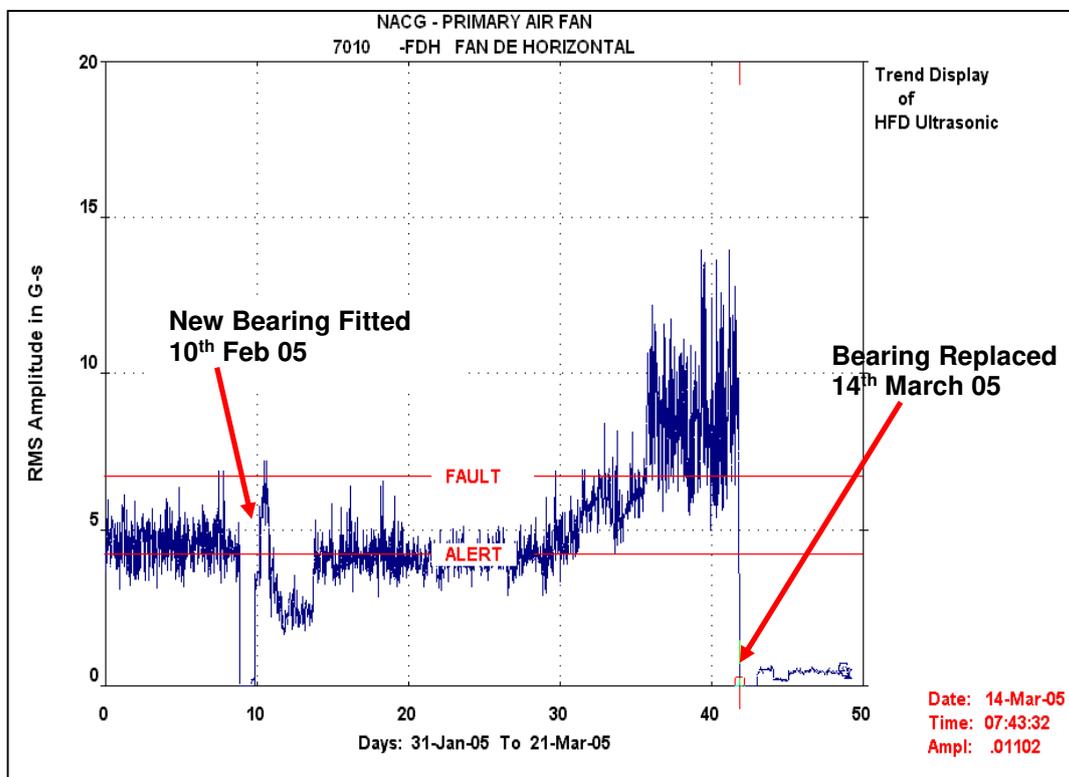
The above online trend is taken off the Fan DE bearing; the HFD levels were increasing steadily until the bearing was replaced on the 14th March 2005. HFD levels respond to bearing distress and lubrication problems.

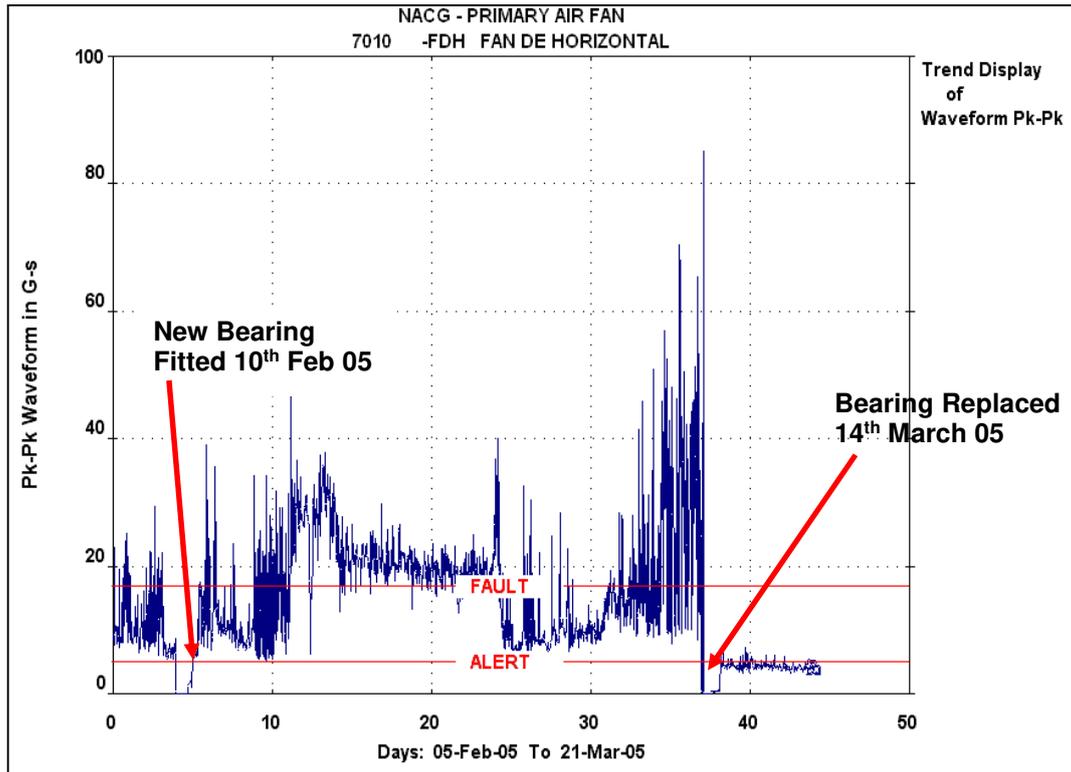
The above online trend is also taken from the Fan DE bearing, this is a different parameter, the PK-PK Waveform level measured in G's, this responds more to impacting problems such as bearing defects, note how the levels increased sharply before the bearing was replaced

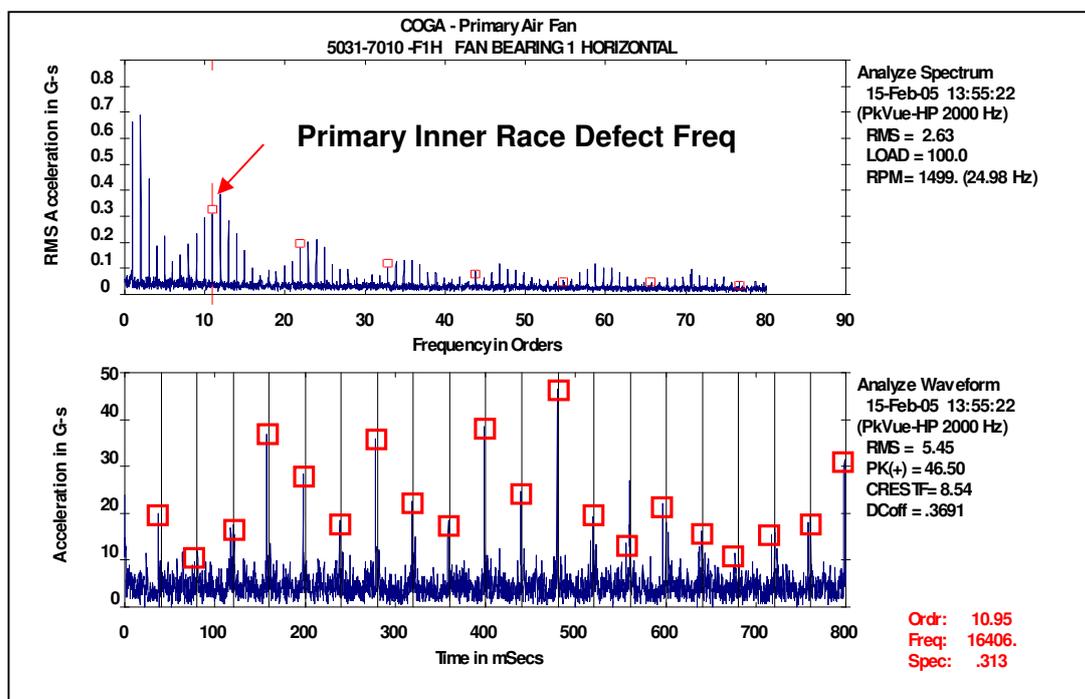
Analysis of spectral and waveform data from the Fan DE bearing clearly showed a severe impacting problem, a dominant once per rev impact was present on the waveform, these graphs were typical of an inner race defect in a localised defect site.

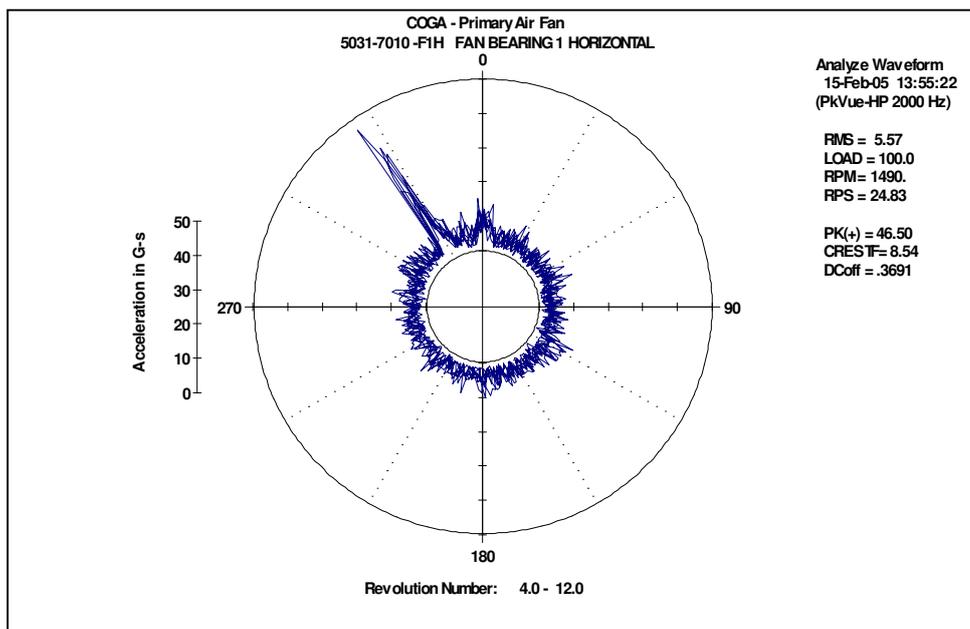
Further Analysis of the waveform using the rotational plot clearly shows the impacting was localised in one position on the inner race.

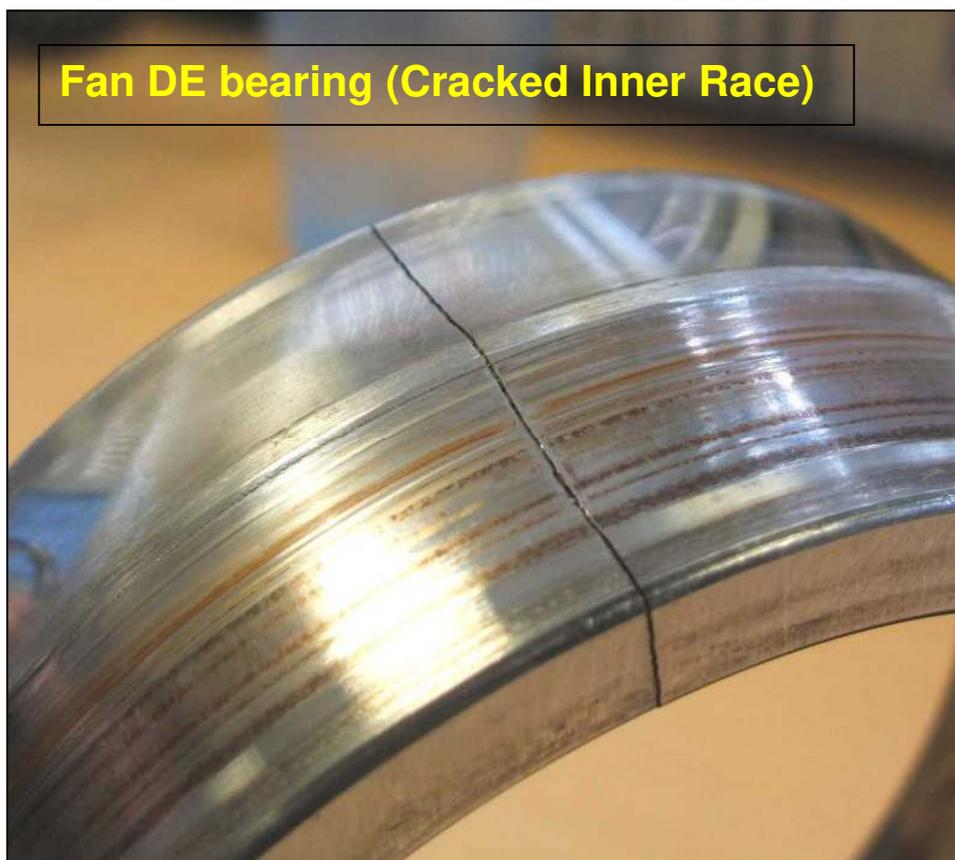
Upon inspection of the fan drive end bearing, a clear crack across the full width of the race was found, this was the source of the high G' impacting levels. The sharp spikes seen on the data were the bearing rollers impacting the crack.

Excessive tightening of the lock nut upon assembly is the most likely caused of the cracked inner race, however a manufacturing fault cannot be ruled out, having the cracked inner race examined should reveal the root cause. Poor lubrication of the fan bearing is also a potential issue and this should be addressed.

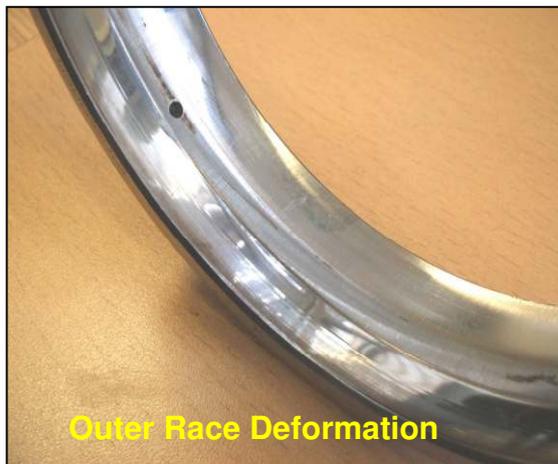
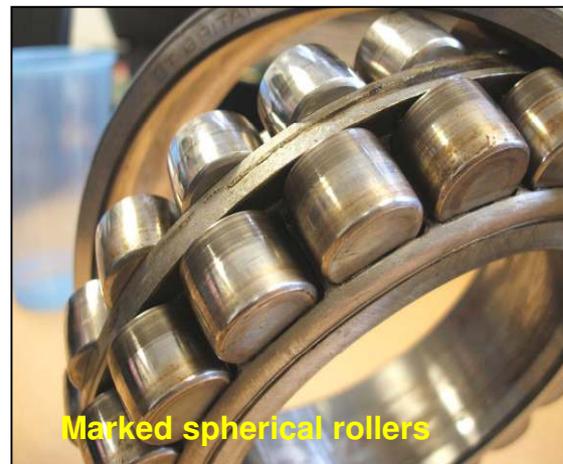
Further examination of the bearing also revealed deformation of the outer race roller path surface and scoring to the rollers (loaded side). It was also noted the condition of the grease within the bearing was poor, indicating a potential lubrication issue as well as the cracked inner race.
