COGA Unit Flue Gas Recycle Fan 5031-7035

Online Vibration Case Study

5031-7035 Flue Gas Recycle Fan (Online Case Study)

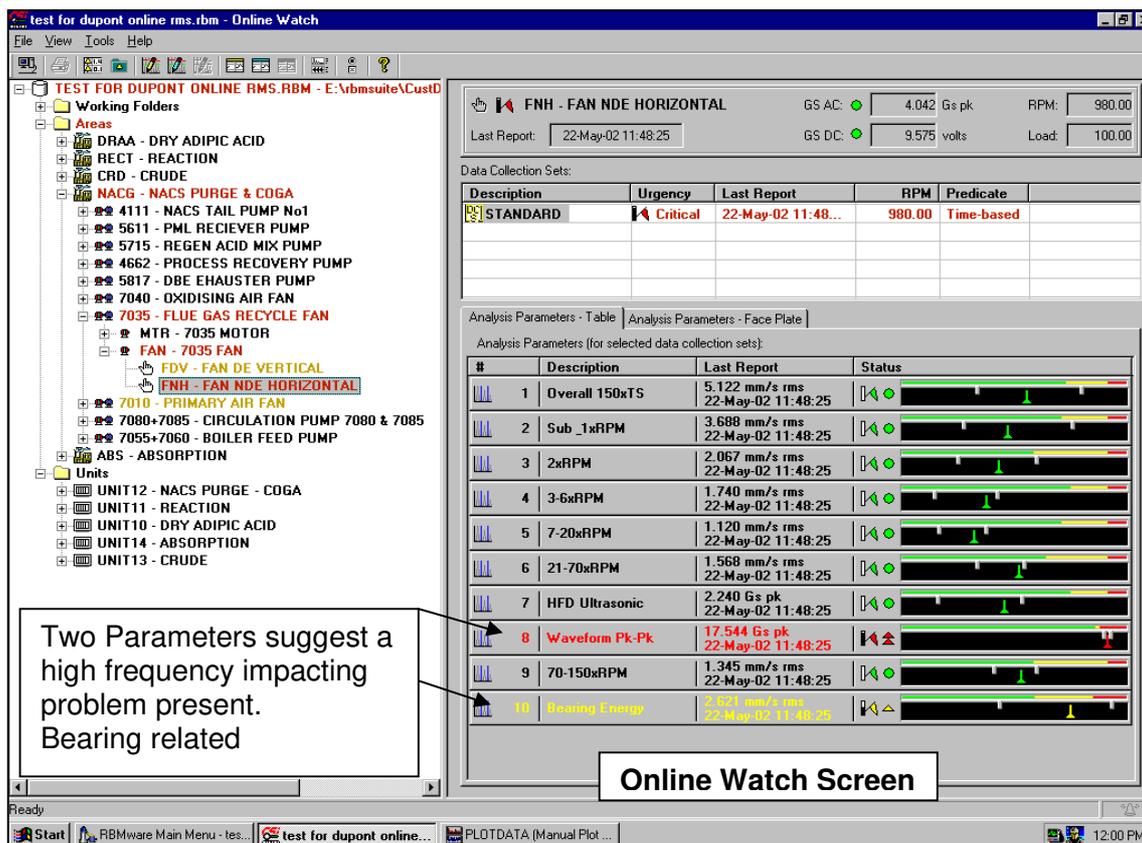
Online Watch Screen

In Mid May 2002 the Flue gas fan sensor (**Fan Non Drive End Fan Horizl**) entered into an alarm condition, the system automatically started rapid data collection. Two parameters were initially in alarm PK-Pk Waveform, (Peak to Peak Value of time waveform measured in G's) and a Bearing energy band also measured in G's. Below is the **Online watch screen** showing the status of monitored plant.

Two Parameters suggest a high frequency impacting problem present. Bearing related

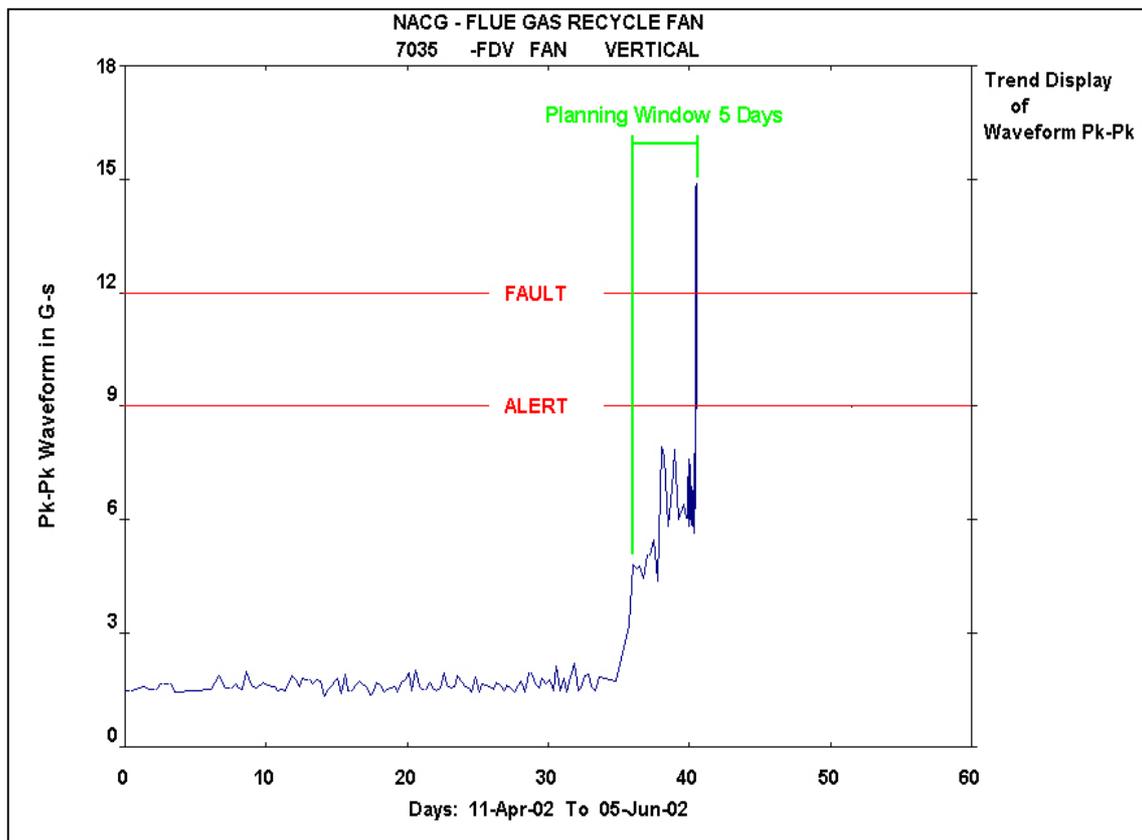
The above online trend is taken off the Fan Non Drive End Sensor; note how quick the fault is deteriorating. Planning windows are rare on the coga unit due to the environmental consequences if the plant is shut down.

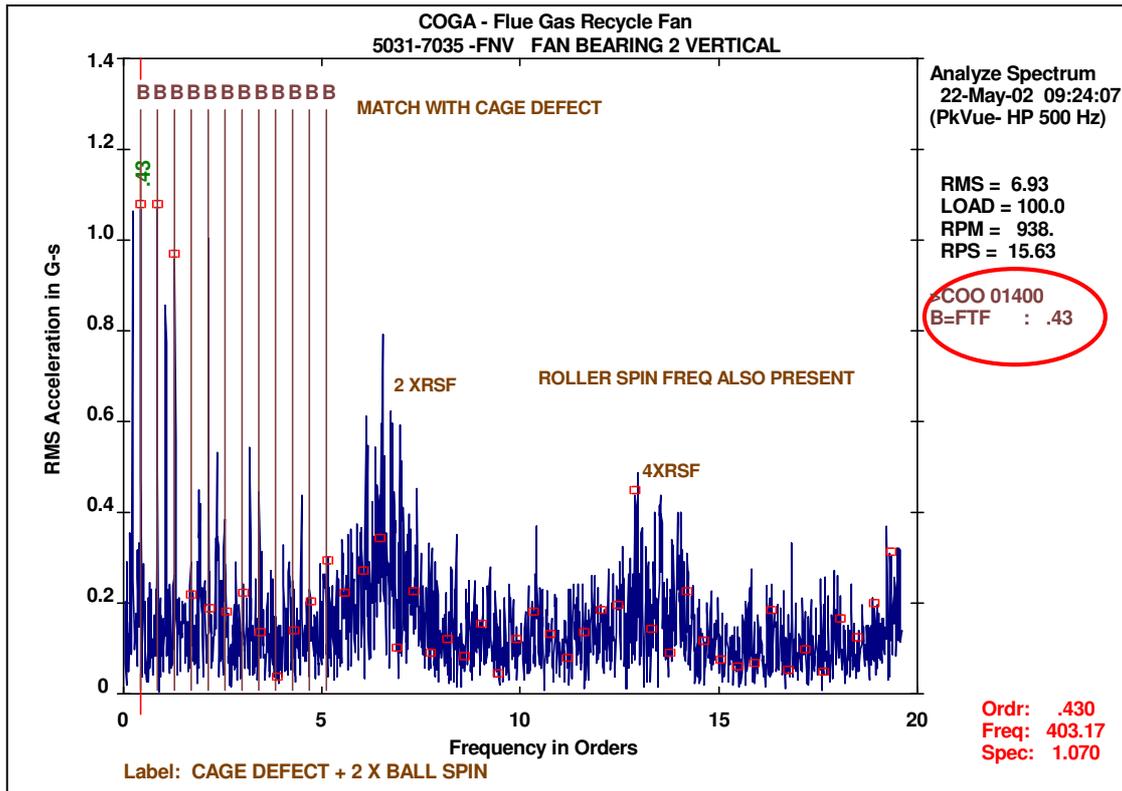
The filtered spectrum above indicates a problem with the cage and rollers on the NDE fan bearing, a clear match is made with the cage (0.4 orders). 2X Roller spin freq is also present due to defects on the rollers impacting the inner and outer races as they rotate. Cage defects are well known to deteriorate quickly.

After discussions with production and maintenance, the reliability team decided to plan for the fan bearings to be changed at the earliest opportunity. New bearings were ordered and a scaffold erected ready for a quick bearing change. The opportunity came on the 21st May when the Dryer Plant shut down on an overload issue. The coga was still running at this point, so a plan was formulated to shut the flue gas fan down in controlled manner so that the coga unit could still be run, but at reduced rates, this was only possible because of the Dryer plant shutting down.

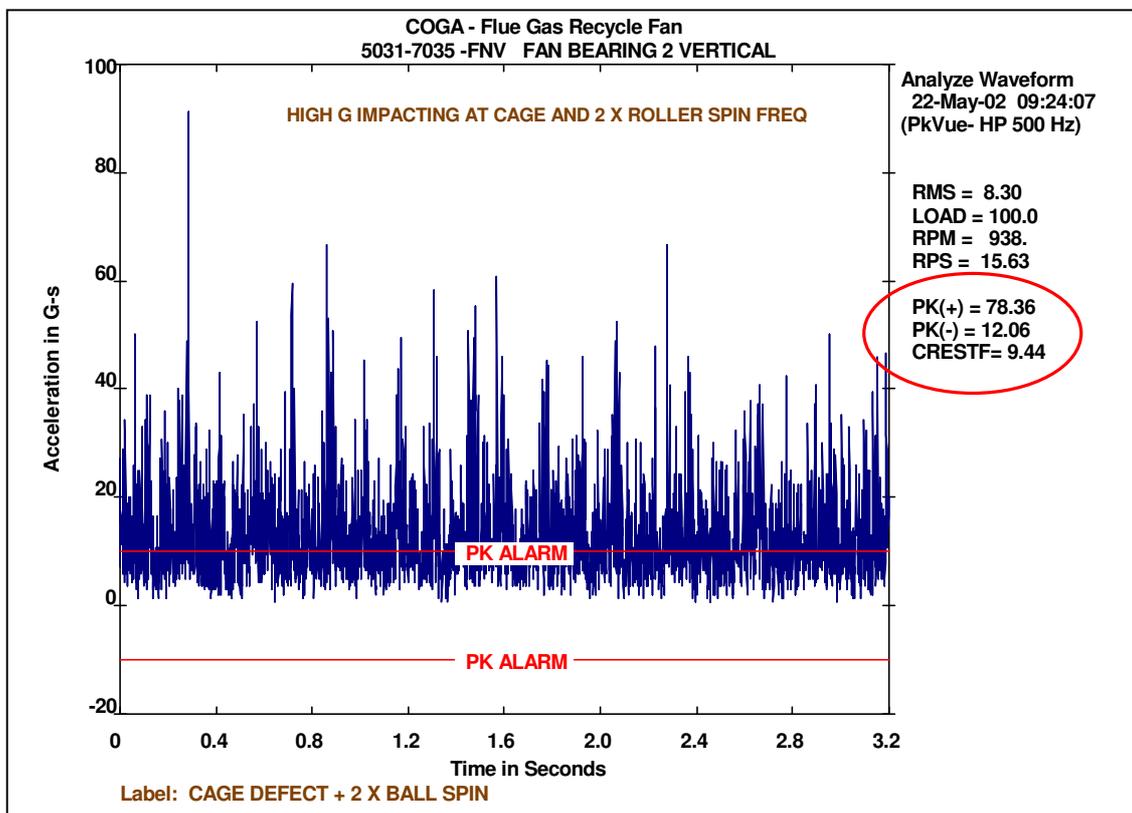
The time waveform shows impacting to 78 G's, severe bearing damage.

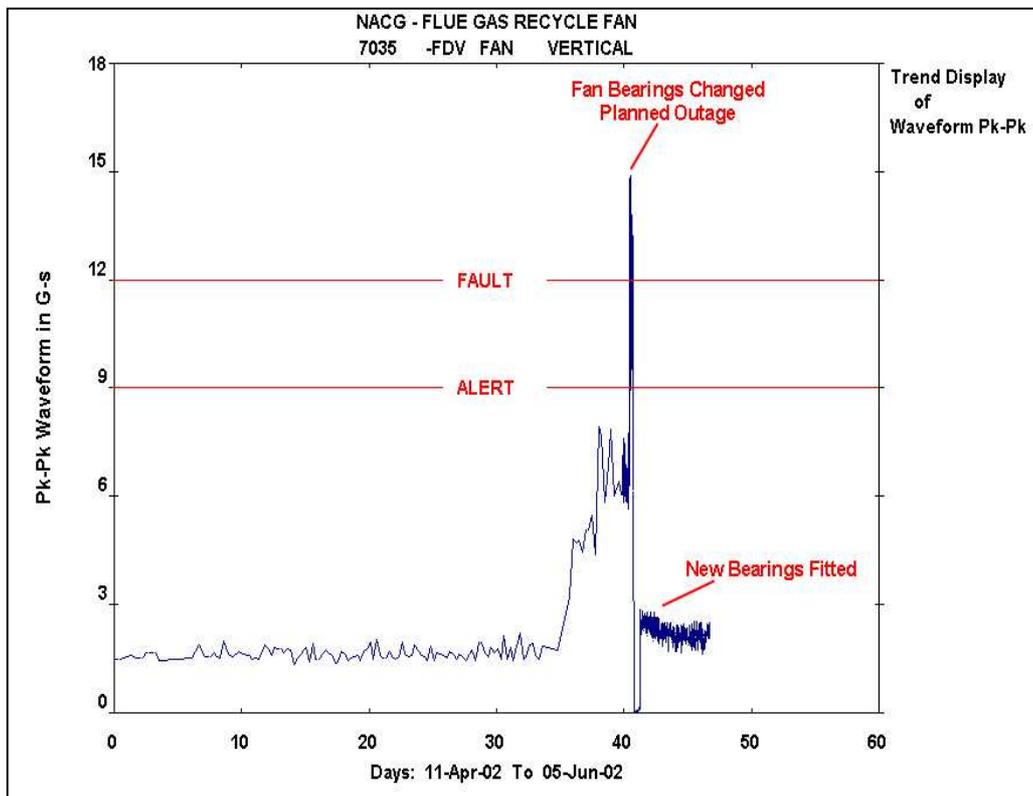
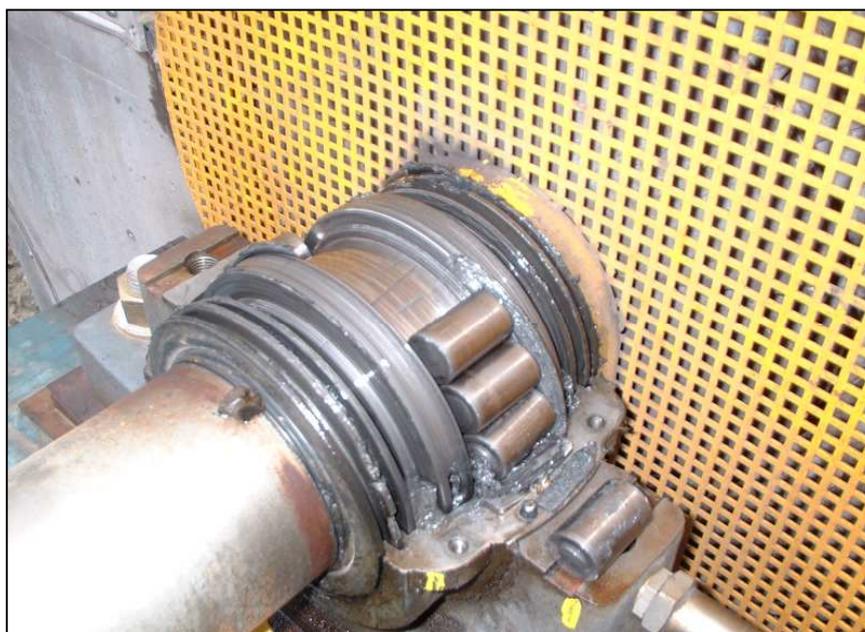
Upon inspection of the bearing it was found that the cage had disintegrated and the bearing had entered the final failure mode. The fan would have failed catastrophically later that day, this would have caused major shaft and fan damage. The bearings were replaced and the fan was running within 6 Hours.

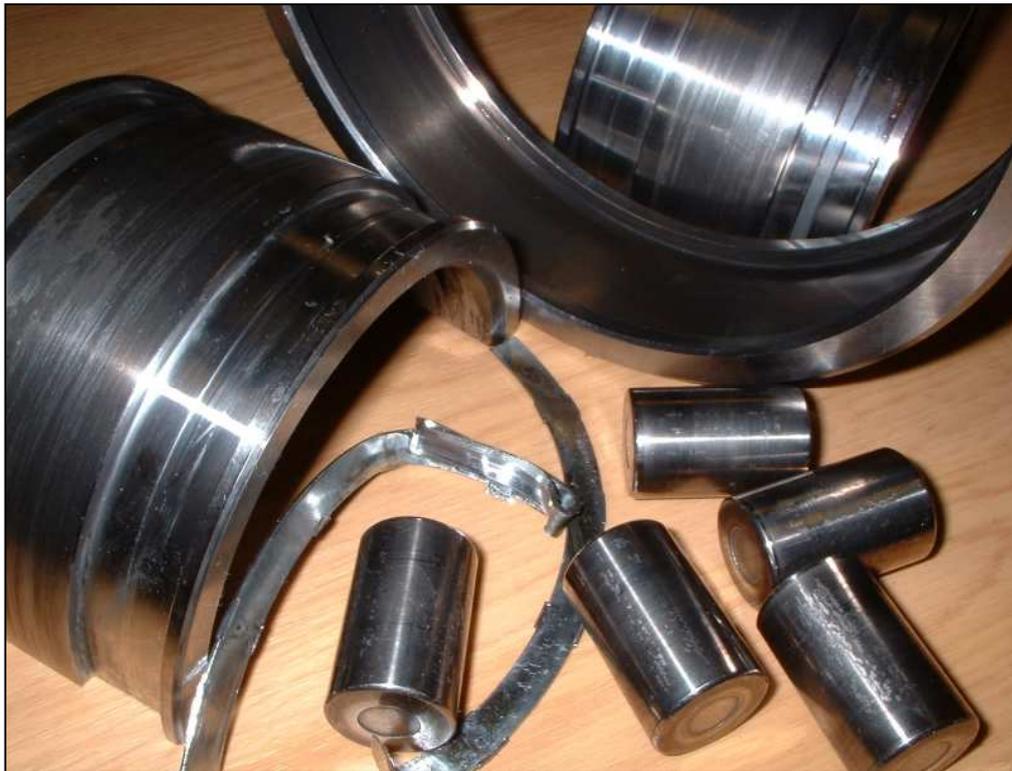
The cleaned up NDE cooper fan bearing showing remains of the cage and the damaged rollers.
