No.1 DRYER. DRAA

Drying Air Fan

5031-3181

5031-3181 Drying Air Fan (Online Case Study)

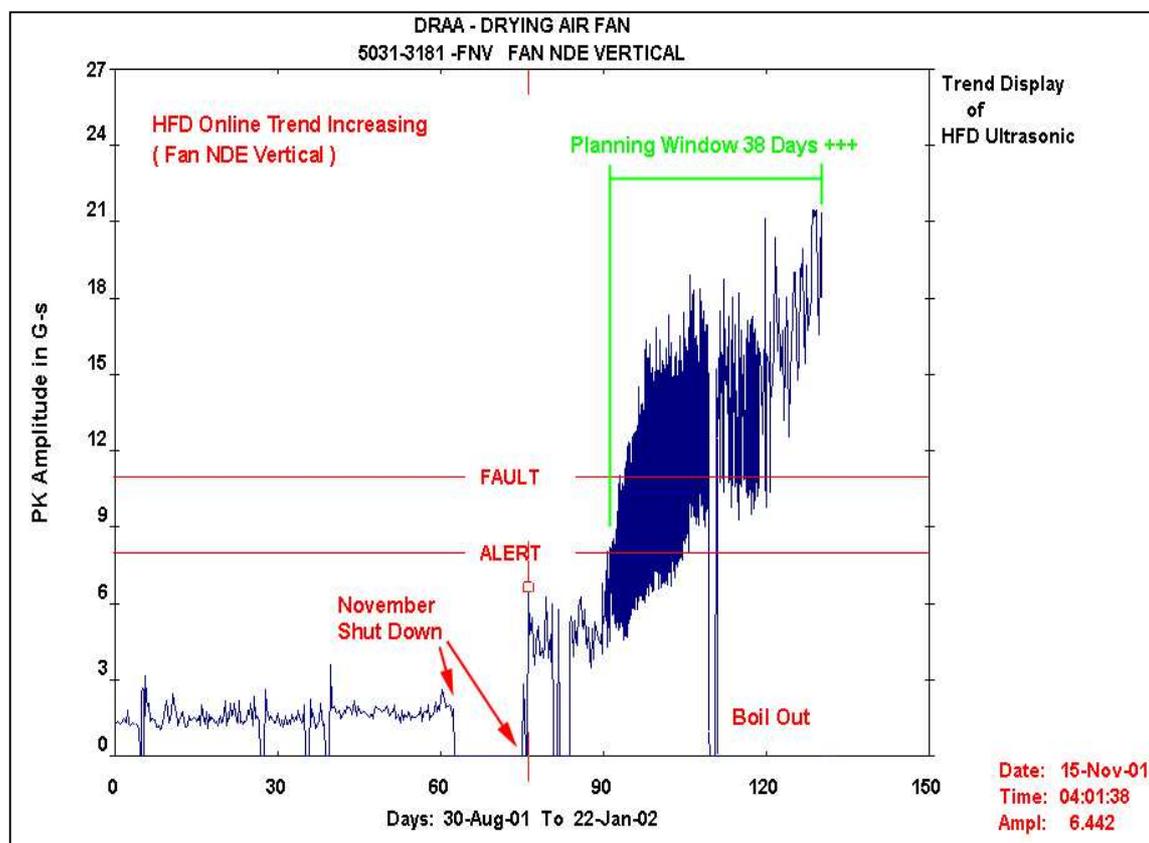
The above online trend is taken off the Fan Non Drive End Sensor; note the step change in vibration after the November Shutdown. The trend above also shows the possible planning options.

After discussions with production and maintenance, it was decided to take advantage of the next boil out and replace the fan bearings within this **planned shutdown**. Boil outs are dictated by production parameters, they are however useful for minor

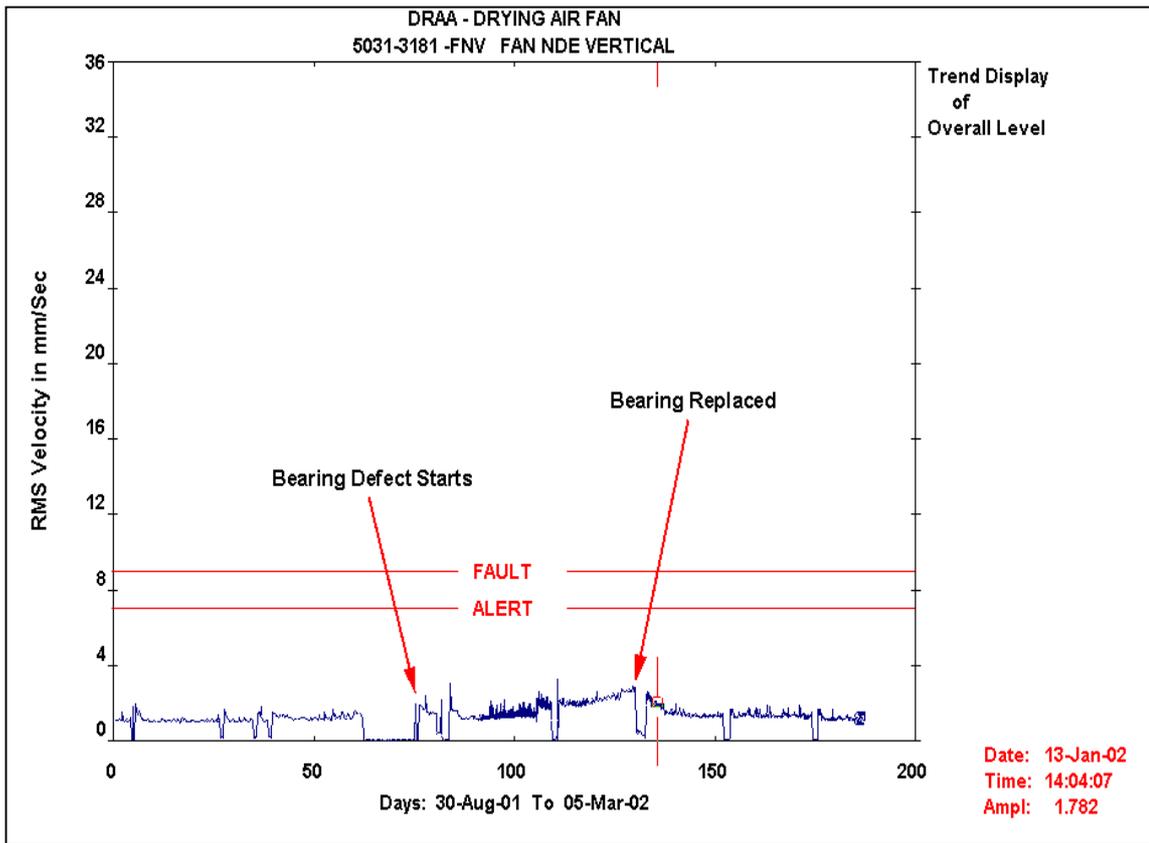
Above trend shows overall level of vibration as bearing defect degrades. Note only a minor change in overall vibration levels.

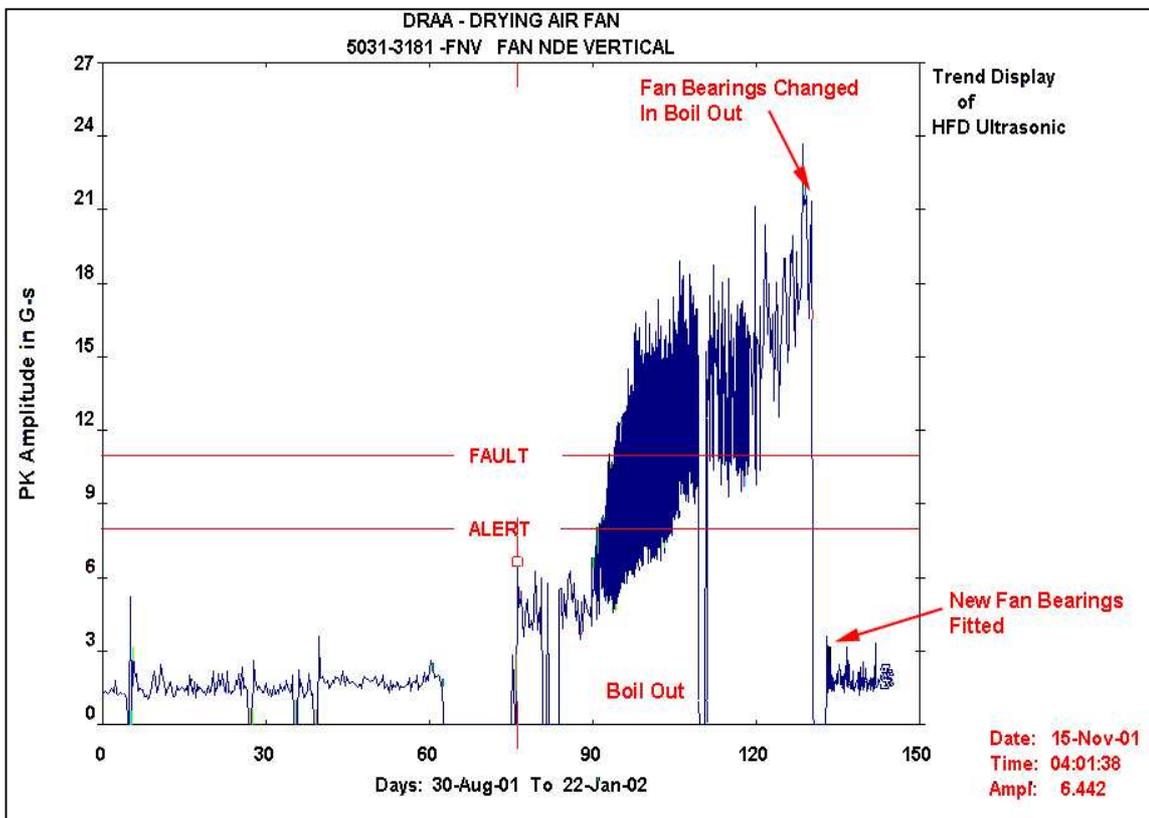
HFD Trend clearly shows bearing defect degrading.

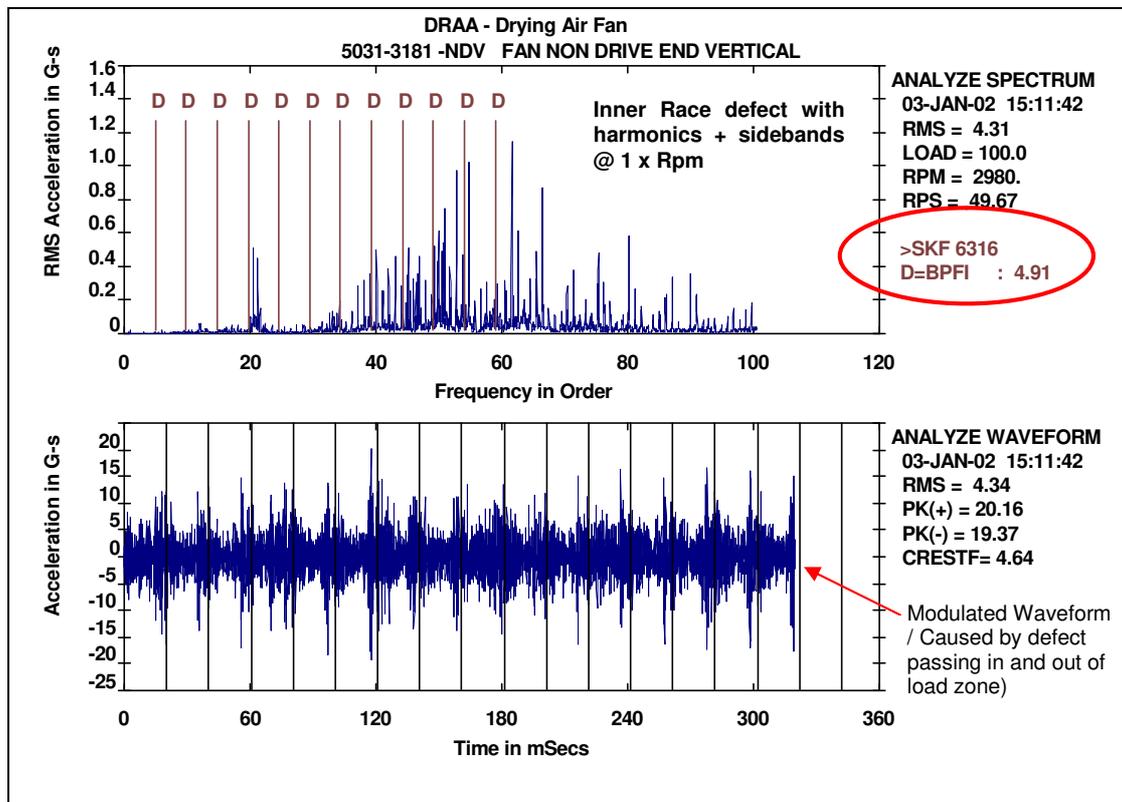
The spectrum above shows multiple harmonics starting from 4.91 orders. This pointed towards a possible bearing defect, all the bearing defect frequencies were overlaid and a match was found with the inner race of the fan bearings (**Skf 6316**). The data indicated that an **inner race defect** was present at the Fan NDE.

maintenance work. Carrying out the fan bearing changes at this time incurred no downtime because it was a planned outage.

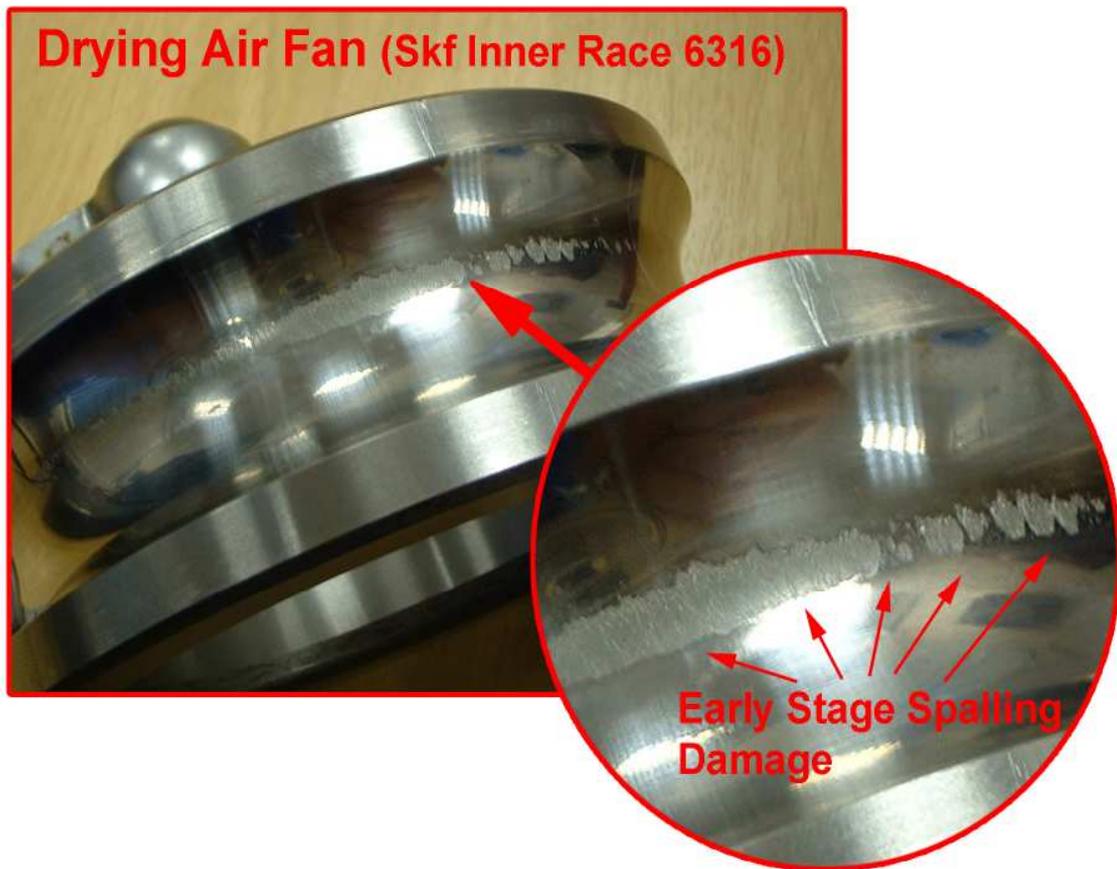
After the Job was completed the fan bearings were inspected for the predicted damage. Below is a photo of the inner race off the fan NDE bearing.
