Case Study – Vibration Analysis

Hammer Mill – Motor Bearing Damage

Vibration Analysis – Hammer Mill, Motor bearing defect

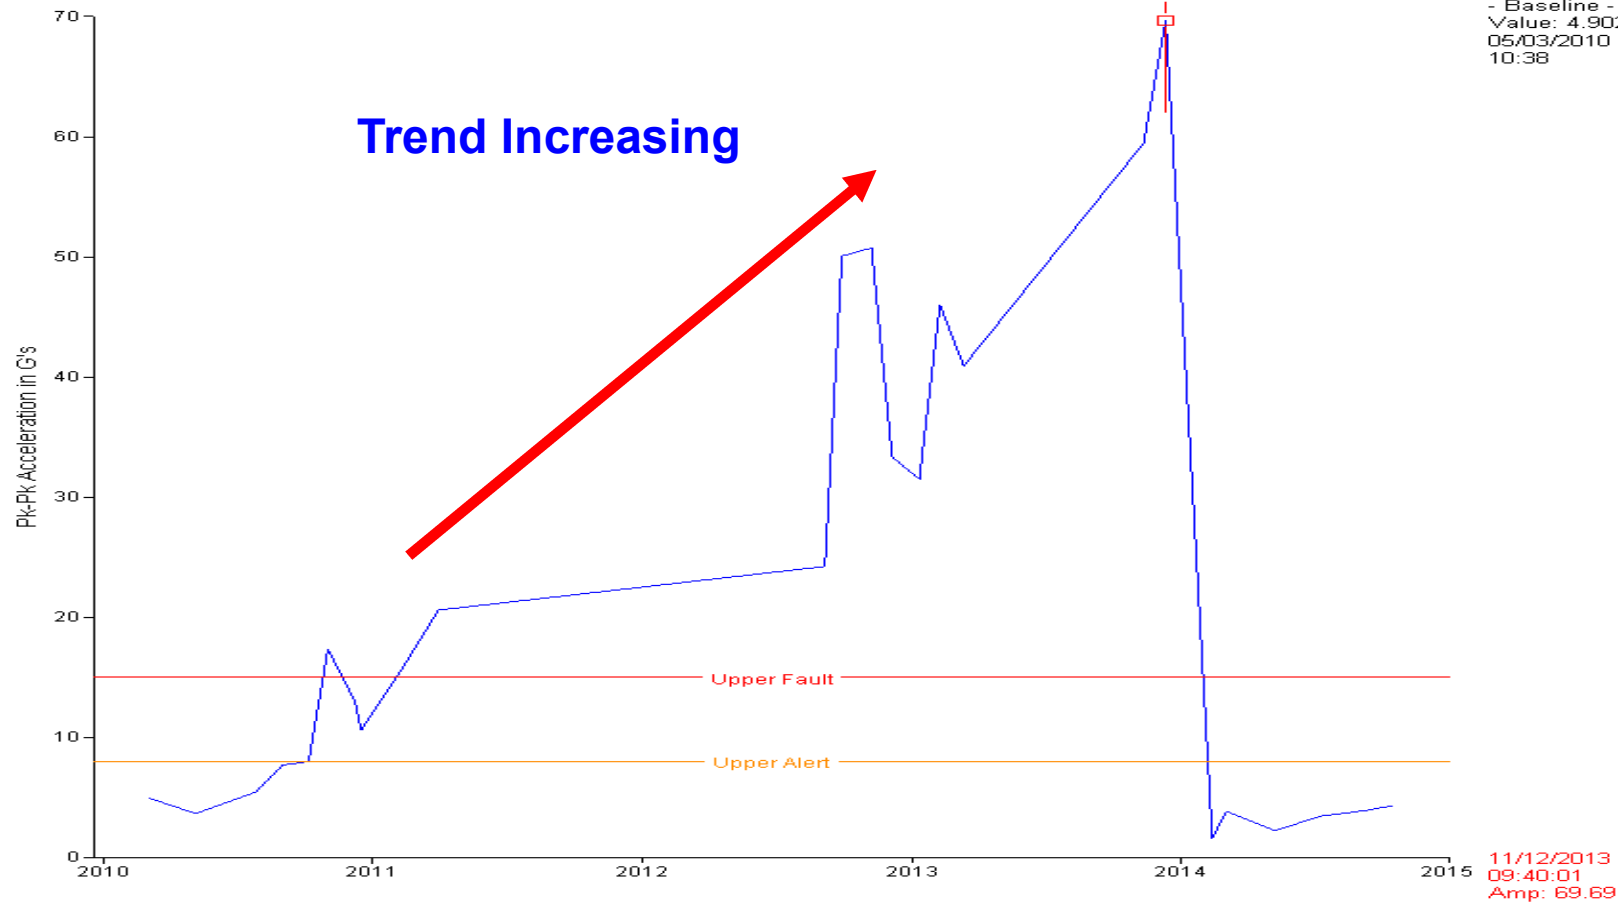
MML - Milling / Mashing & Liquefaction / M209A - Hammer Mill A
MIP - Motor Inboard Peakvue

Motor DE bearing

Waveform P-P G levels increased since 2010 to 69 G's

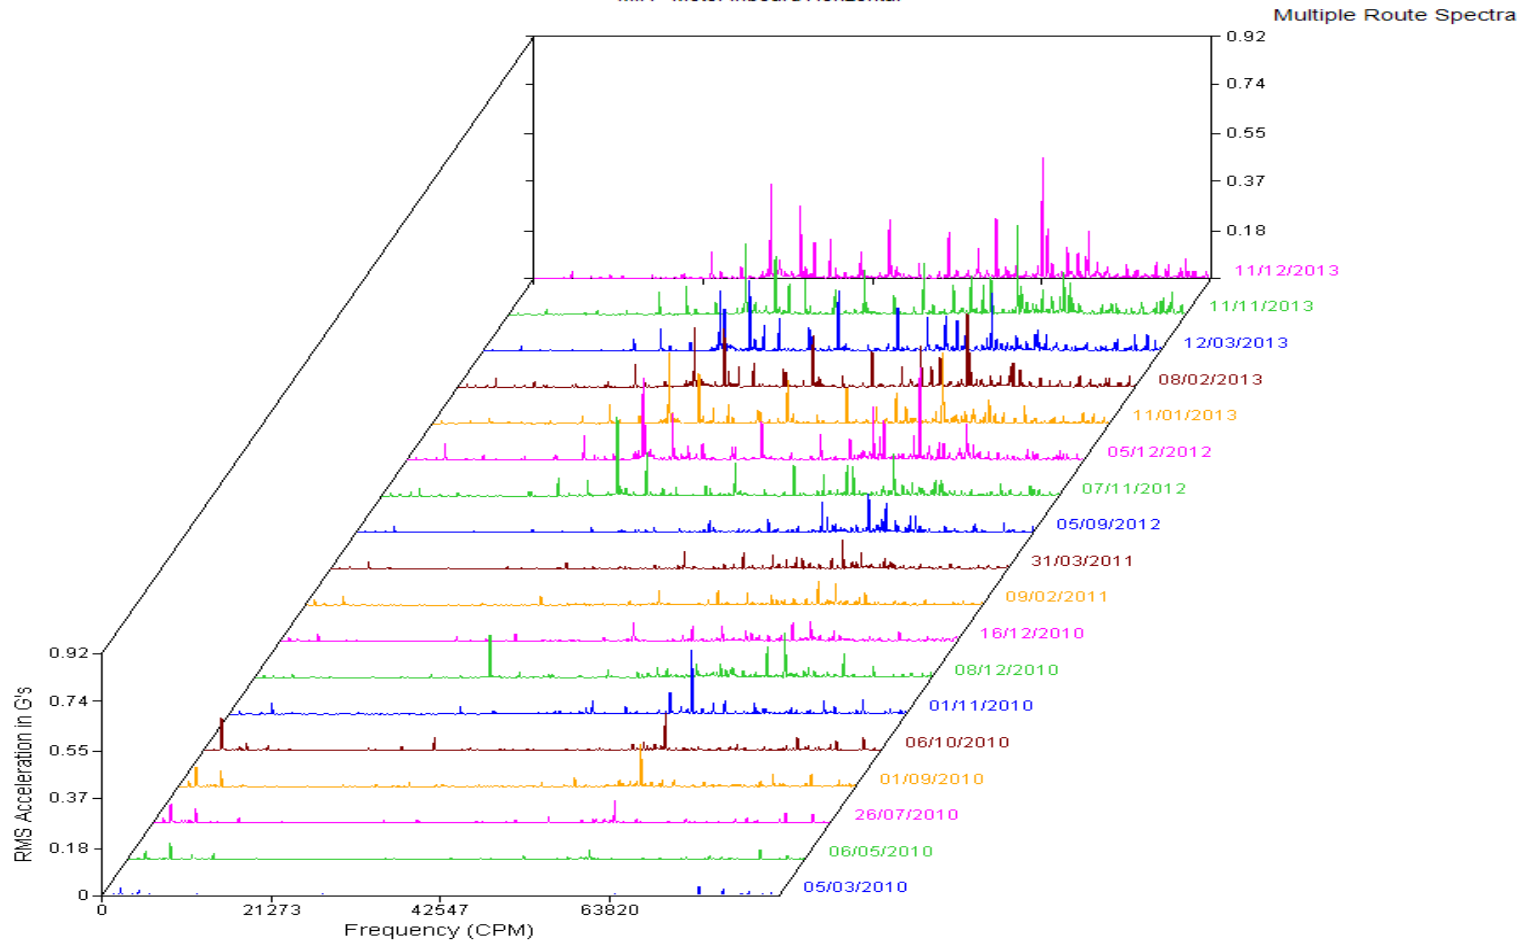
MML - Milling / Mashing & Liquefaction / M209A - Hammer Mill A
MIH - Motor Inboard Horizontal

Motor DE bearing & NDE bearing
Increasing activity in spectral data

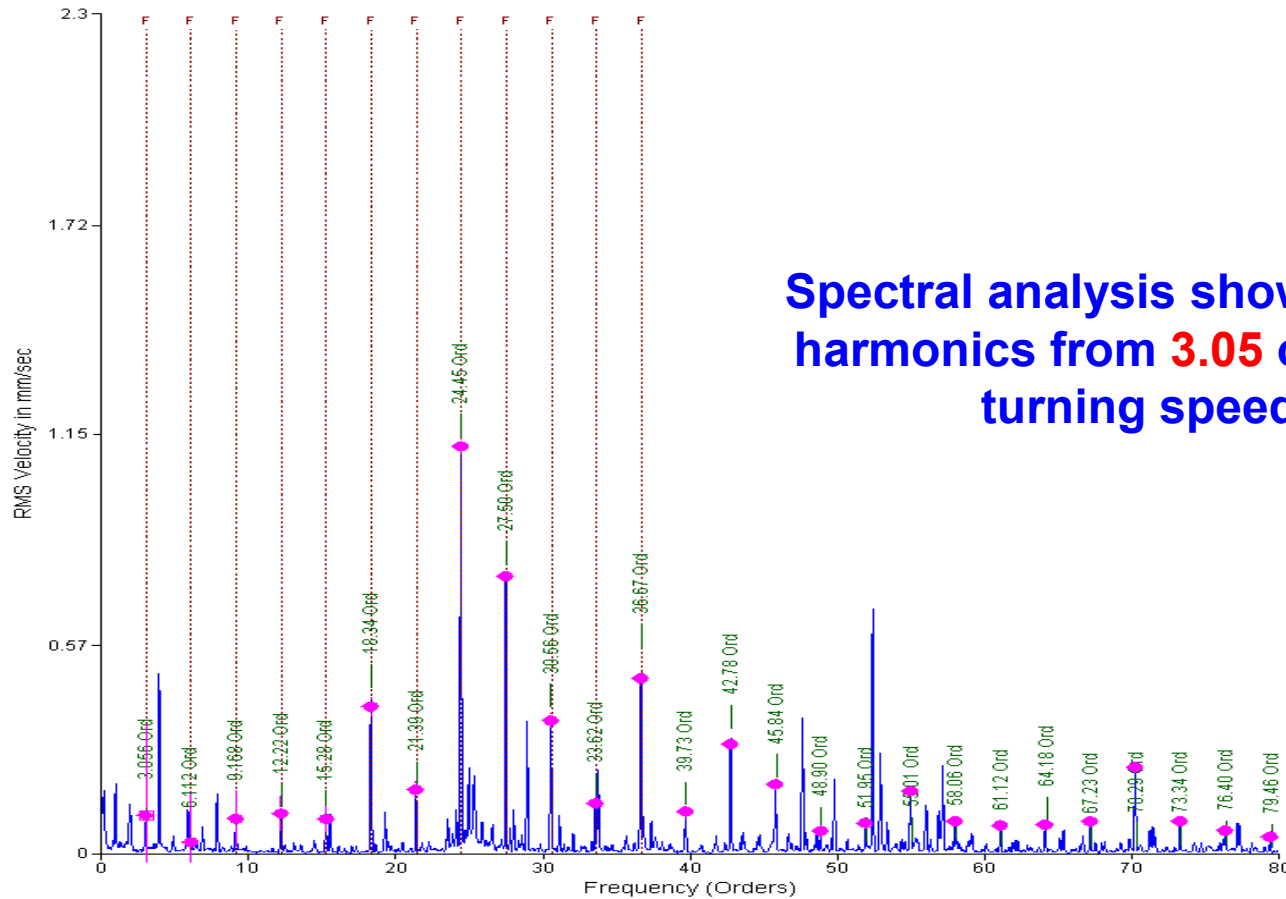
MML - Milling / Mashing & Liquefaction / M209A - Hammer Mill A
MIH - Motor Inboard Horizontal

Route
2.247 V -DG
RMS = 2.248
LOAD = 100.00
RPM = 1220.5
(20.34 Hz)
SKF 6322
F-BPFO
3.056 Orders

Defect frequency match with SKF 6322 bearing outer race damage (BPFO)

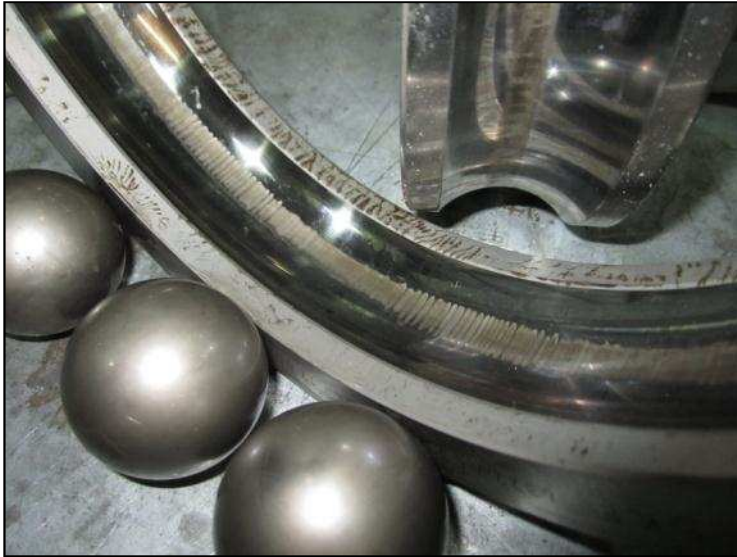
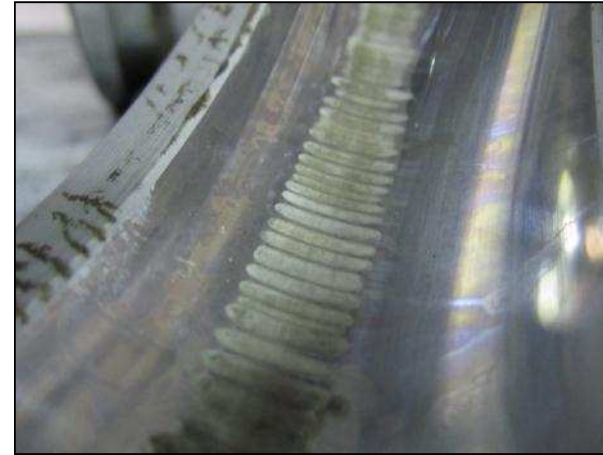
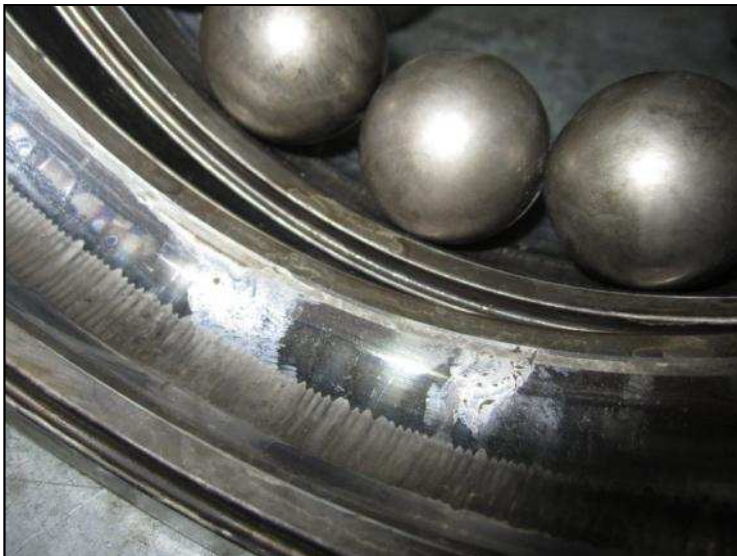
Motor bearings removed for inspection in early 2014

Clear damage on outer race indicating electrical erosion as root cause of bearing damage

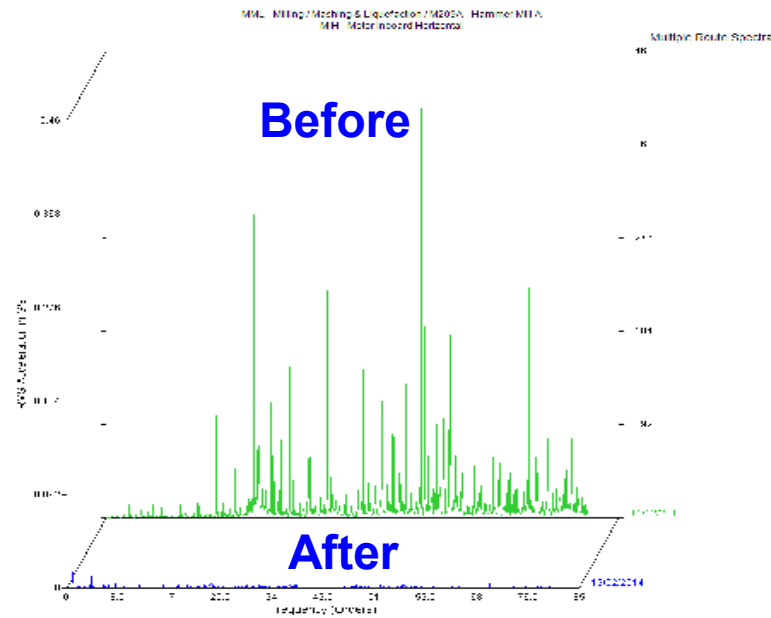
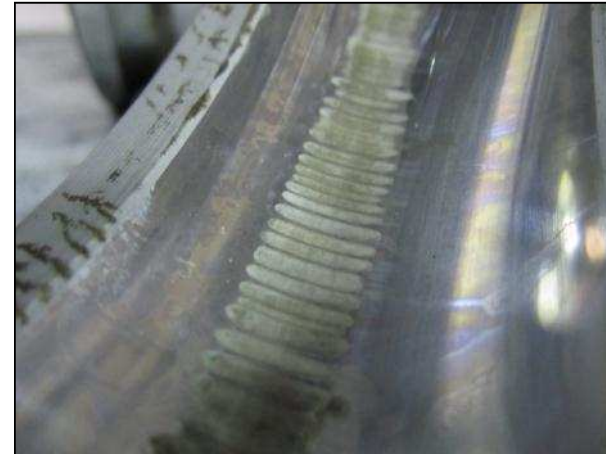
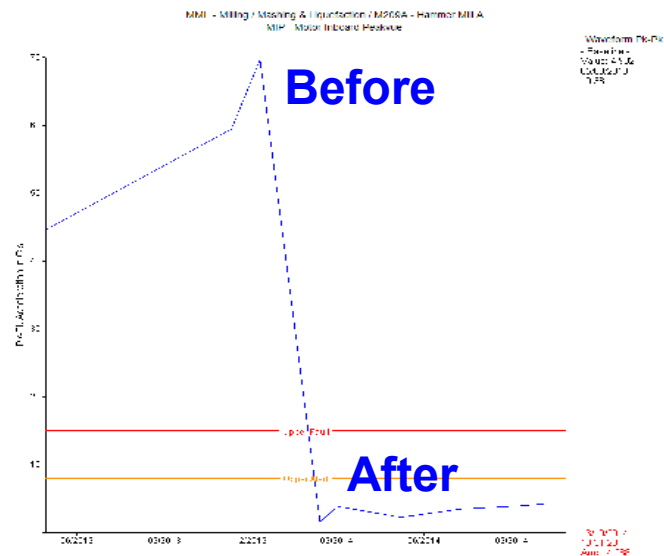
Both motor bearings show severe fluting on outer races, damage also present on inner races, balls discoloured

Stray eddy currents causing electrical erosion of the bearings

Fitted insulated bearing to the NDE of the motor as cure.
