# Case Study – Wireless - Kappa X Gearbox Brg Defect

Food Sector

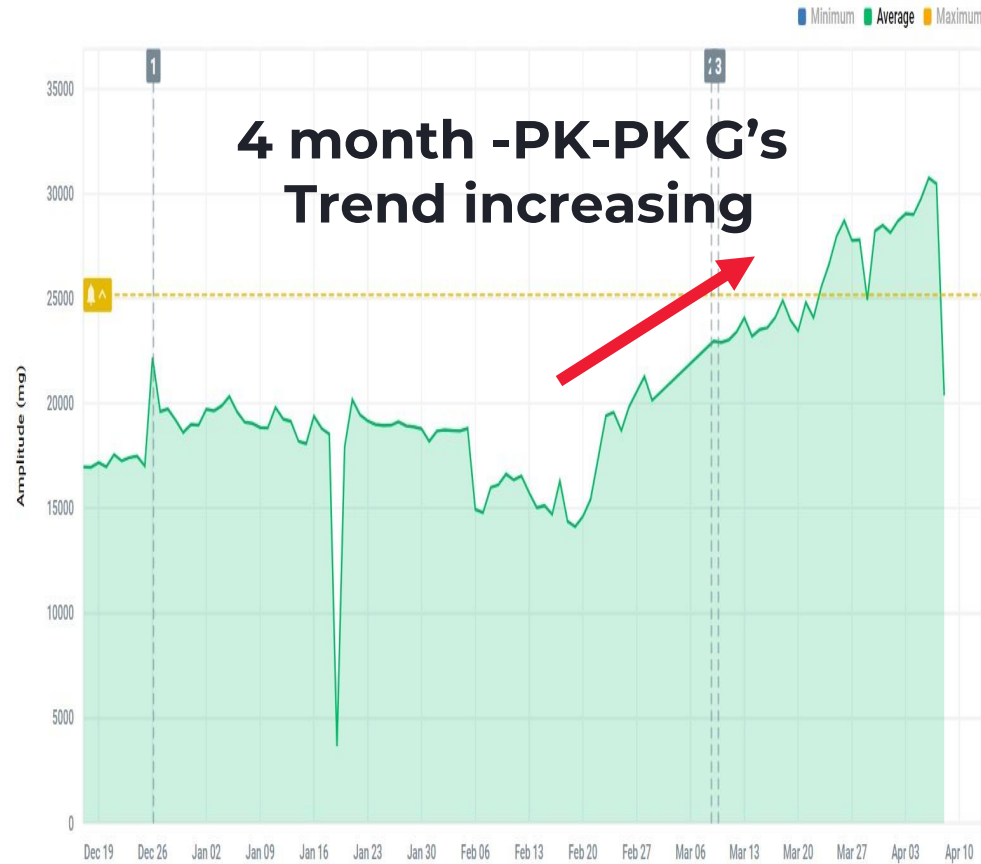
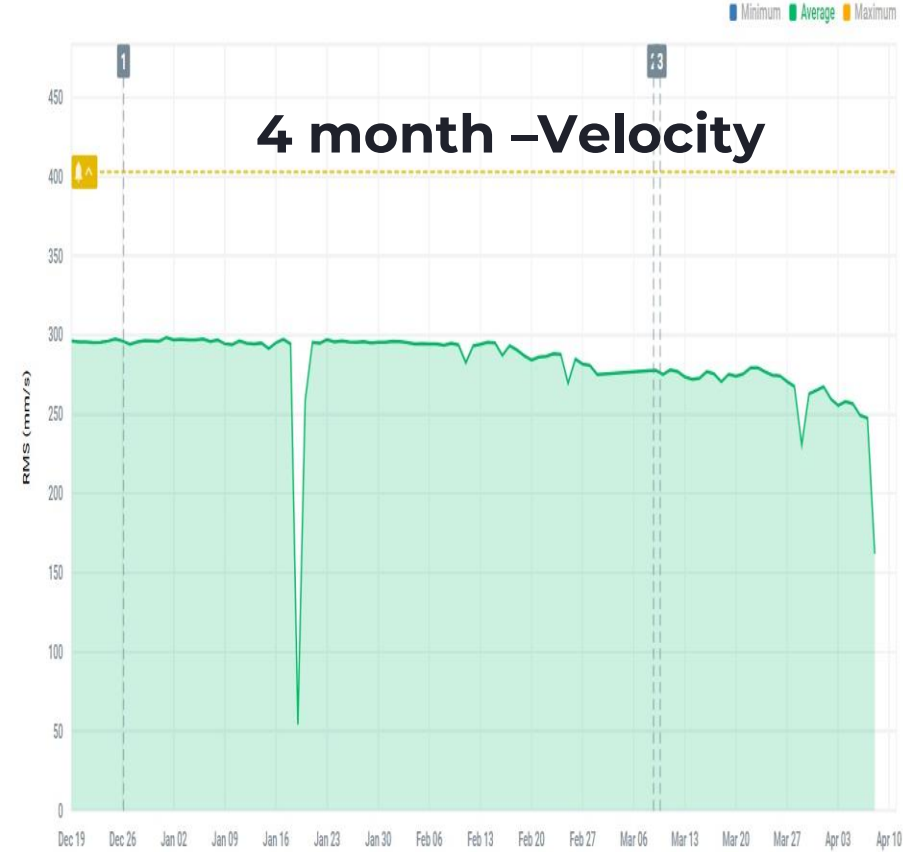
# Gearbox 2 - Trends

- High G levels increasing trend PK-PK G's
- Velocity levels steady

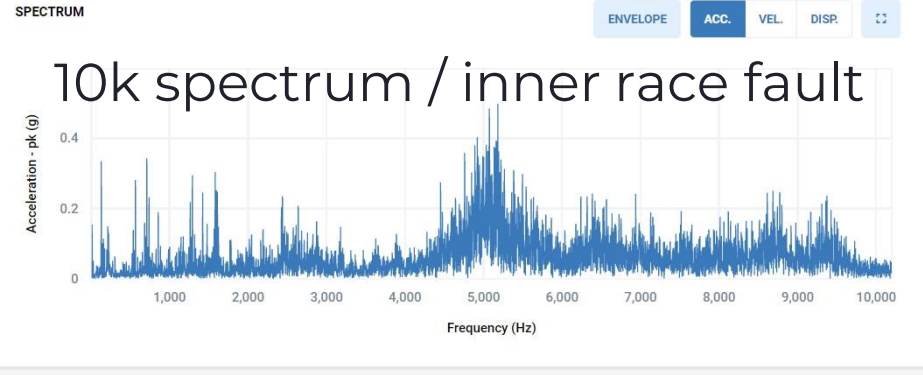
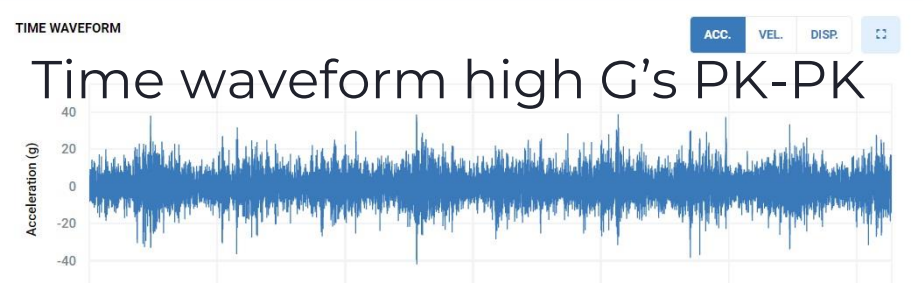
# Gearbox 2 – Spectral & Waveform Data

TIME	10:07:03 on 17th March	
OA VEL.	22.8 mm/s	0.899 in/s
OA ACC.	6.52 g	2519 in/s <sup>2</sup>
PK-PK ACC.	80.7 g	31158 in/s <sup>2</sup>
CREST FACTOR	5.54 (ratio)	
SAVED RPM	843

- Inner race defect confirmed
- 9.2 orders non sync

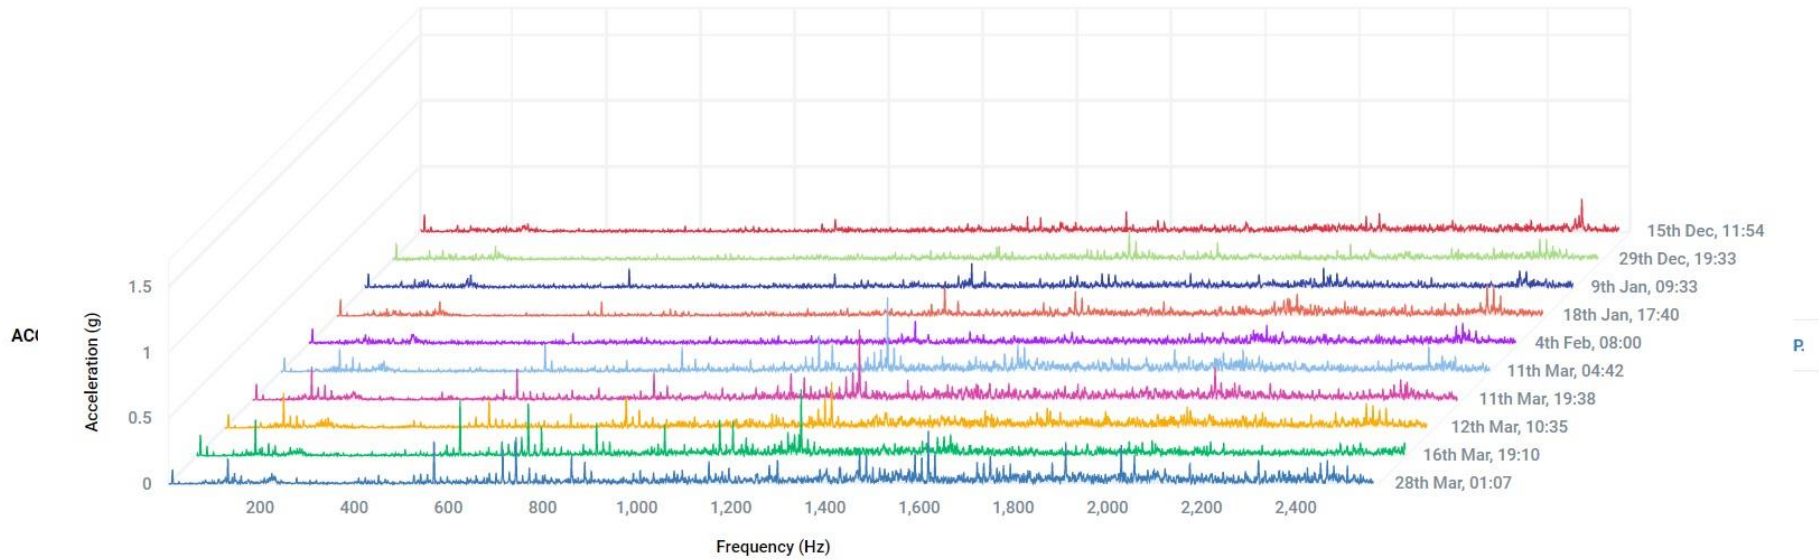
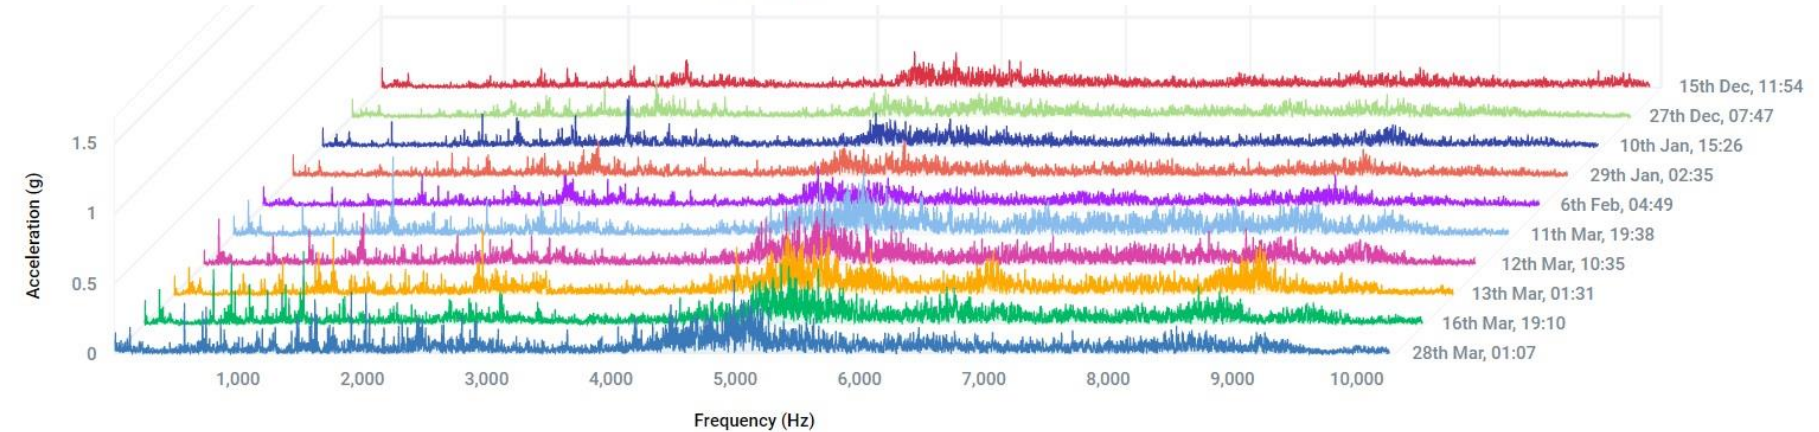
# Gearbox 2 – Spectral Historical Data

- 2.5K degradation waterfall plot
- 10K degradation waterfall plot

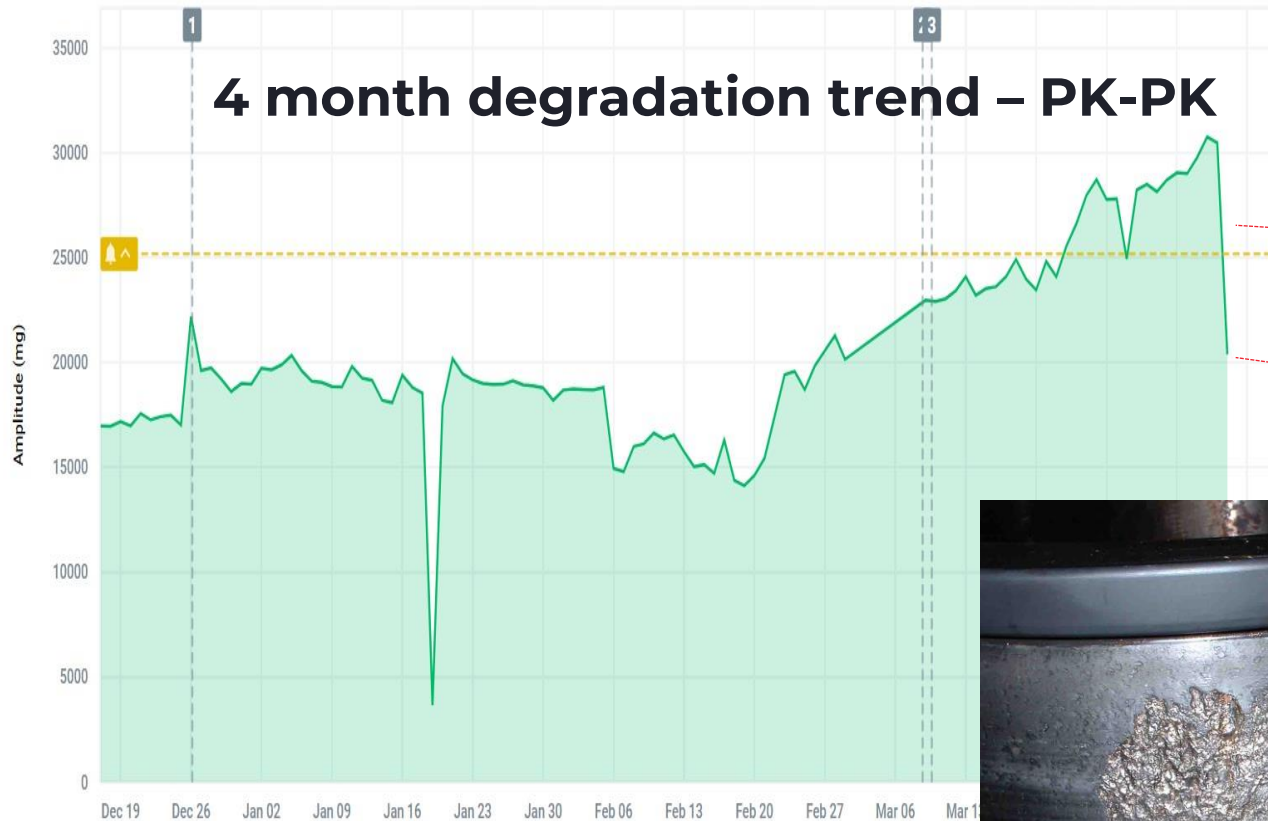
# Gearbox 2 – Nursed through to the end of production campaign

- High G levels increasing trend PK-PK G's
- Unit shut down, end of campaign. Wireless saved shutting the plant down to replace the gearbox.
- **Estimated operational cost savings £42000**

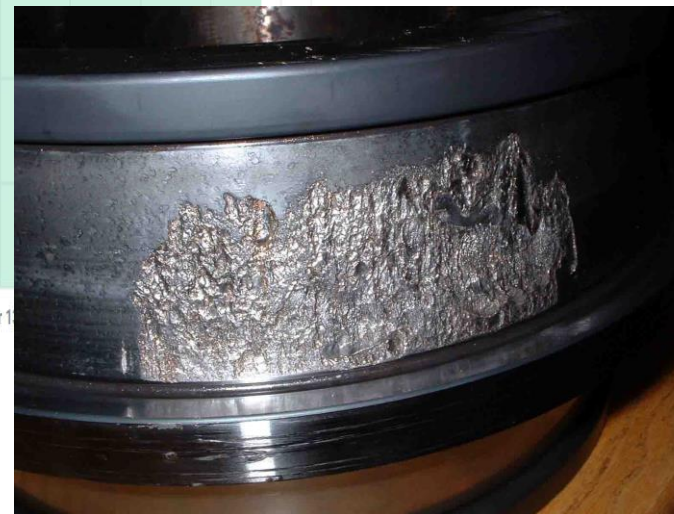
Inner race defect gearbox 2
