# Case Study – Wireless - Kappa X Fan Bearing Lubrication Issue

Power Plant - Food Sector

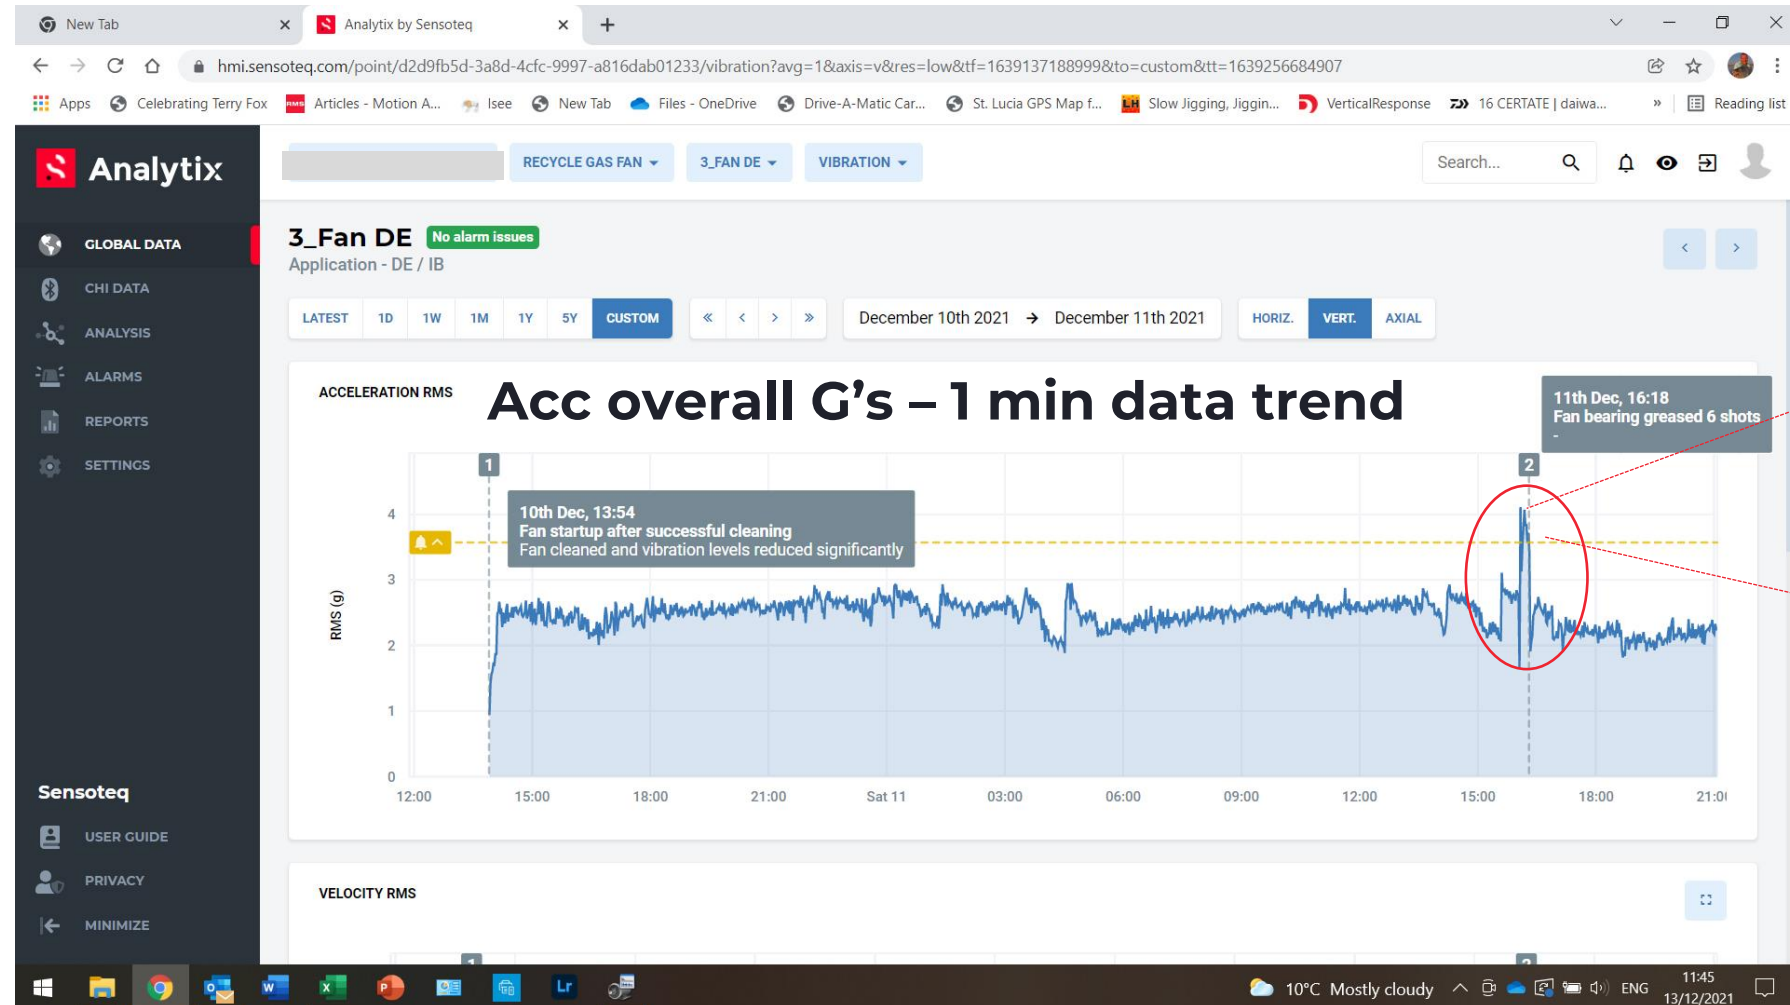
- Sharp Increase in Overall G levels from 2.2G's to 4.1G's
- Fast reaction from operations - 6 Shots of grease added
- Overall Acceleration Distress levels reduced to normal quickly and stayed low.

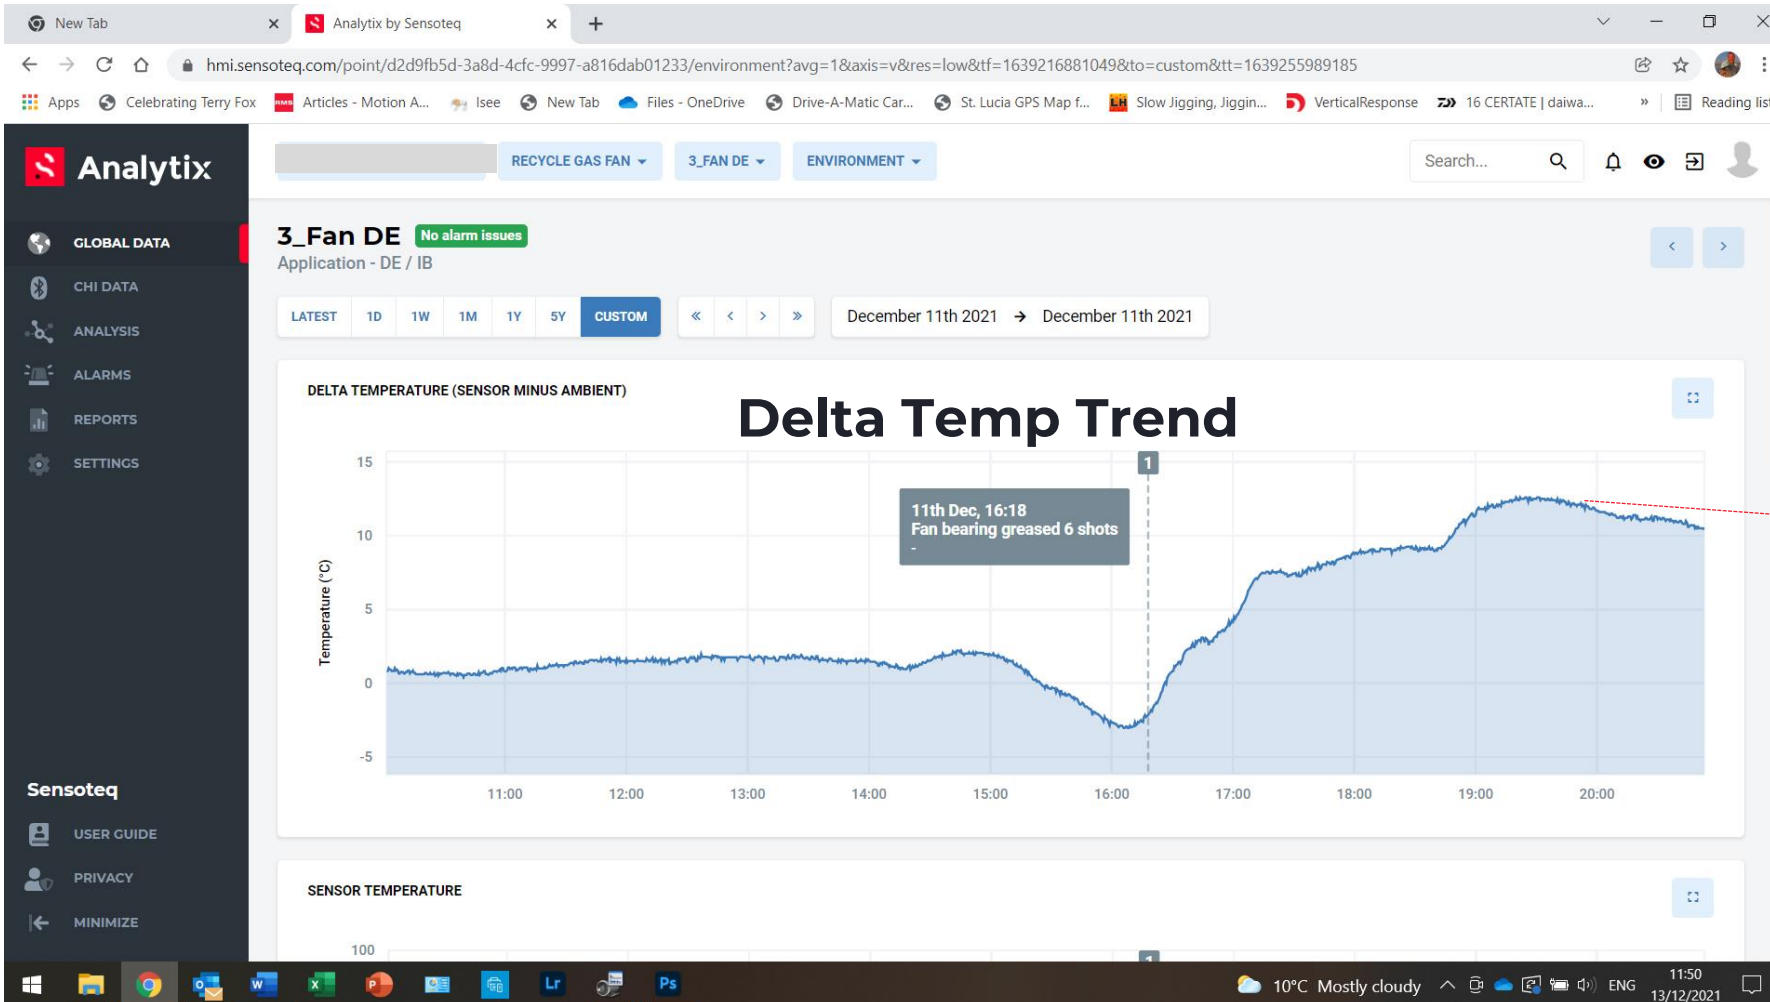
- Expected temp increase after greasing
- Temp levels started to reduce after a number of hours.
- New fan bearing design (Mono Block) planned to replace split bearing design to improve reliability of this fan.
- Possible fan bearing failure avoided – **Estimated cost saving £56K**
