Case Study – Wireless - Kappa X Unbalance Problem

Power Plant - Food Sector

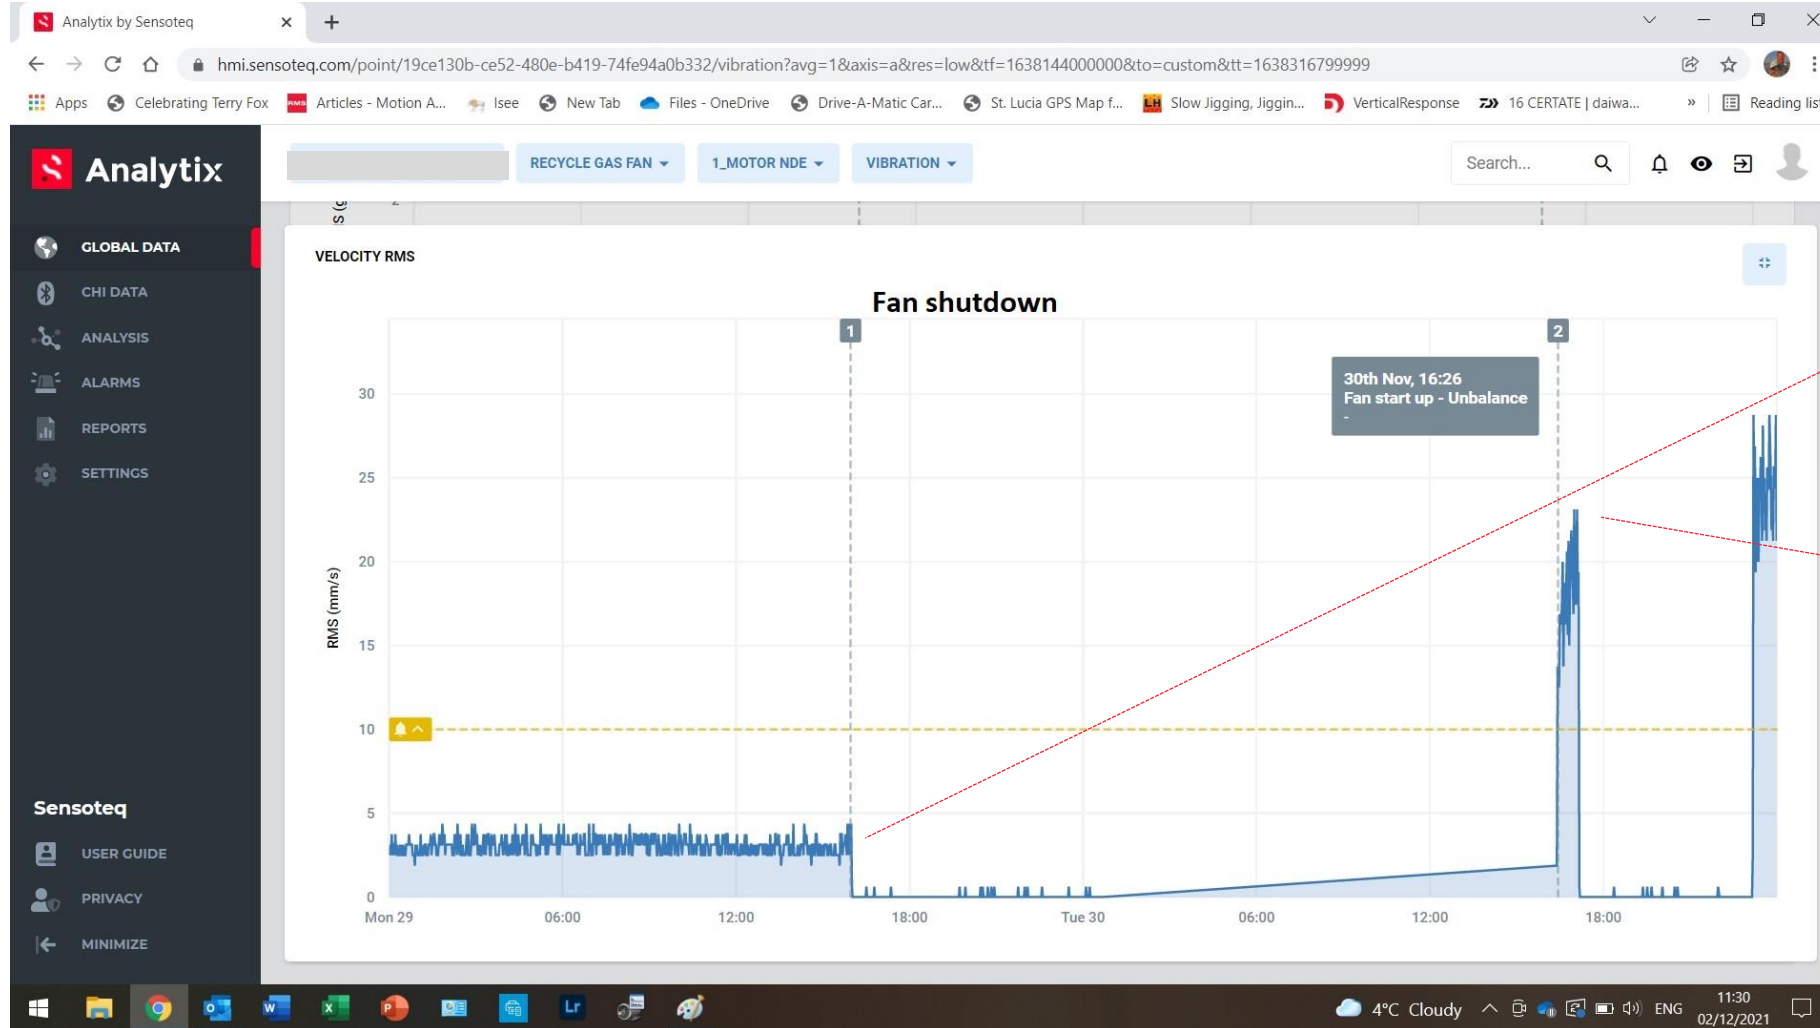
Short term 1 min trends – Motor NDE – Velocity mm/sec RMS

- Fan shut down as one dryer was brought offline.
- Upon restart, sharp increase in velocity levels up to 20mm/sec RMS, previous levels were 4 mm/sec RMS.
- Alarms broken PDM team alerted

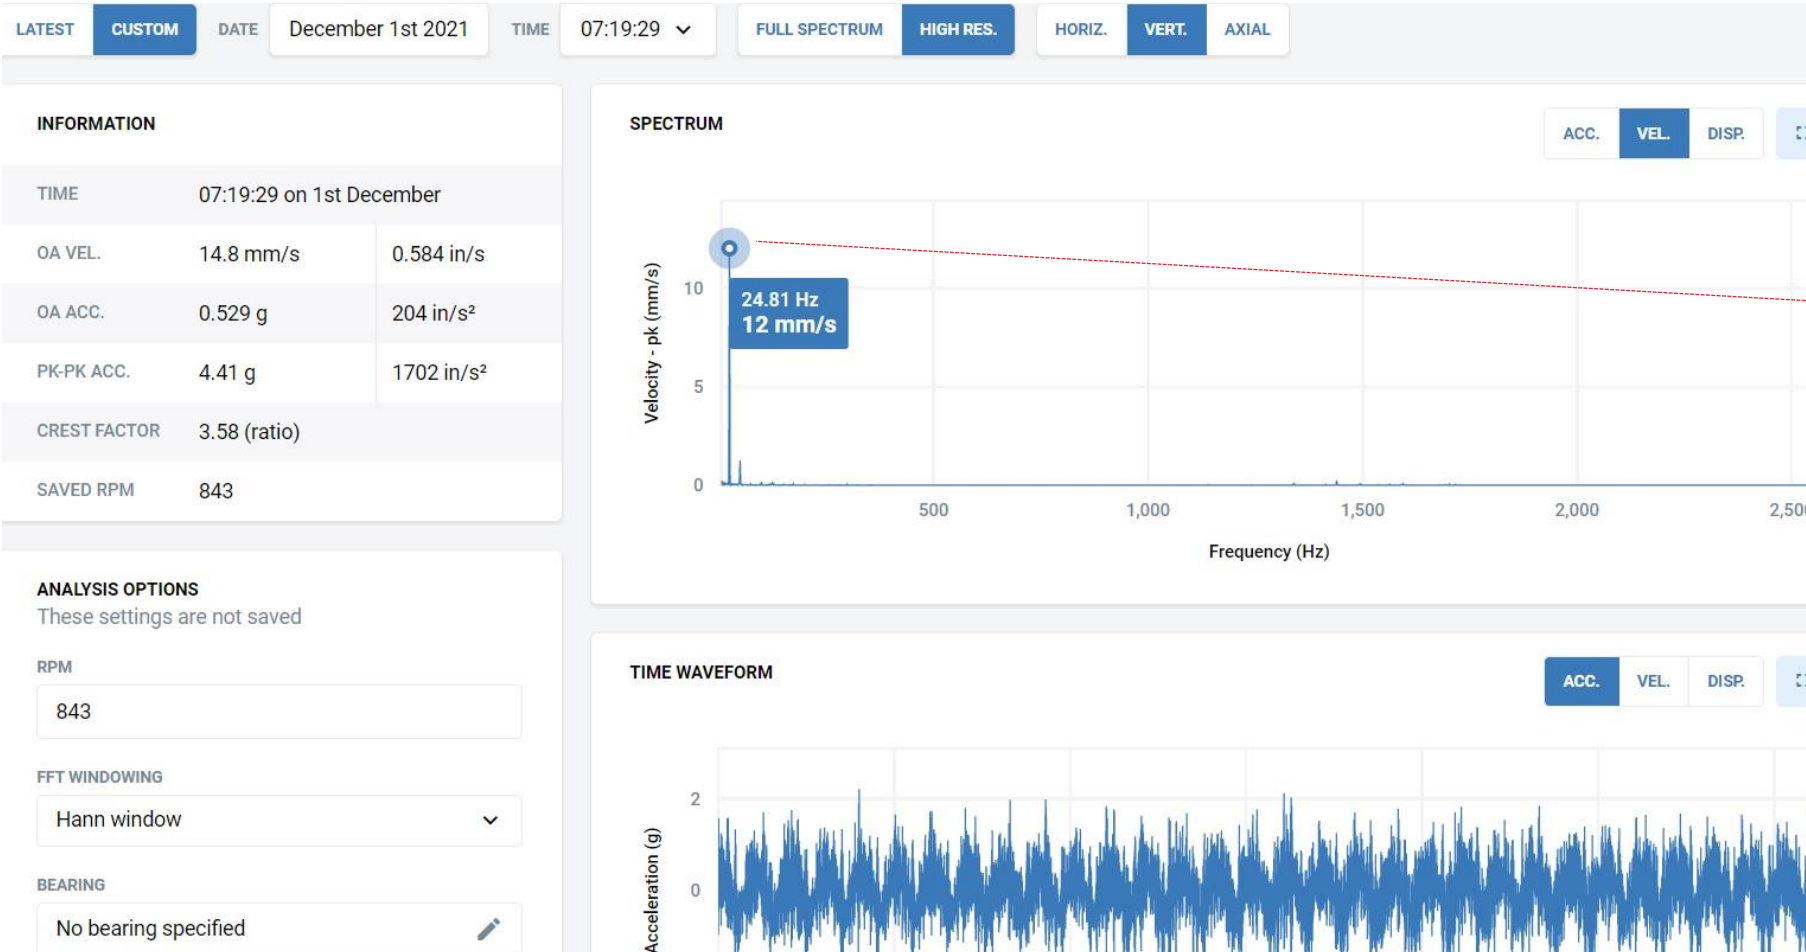
Spectral / Waveform Data – Motor NDE

- Spectral data showed high 1XRPM, suspected unbalance
- Low G's on waveform
- Decision was made to inspect fan impellor for signs of damage or dirt build up.

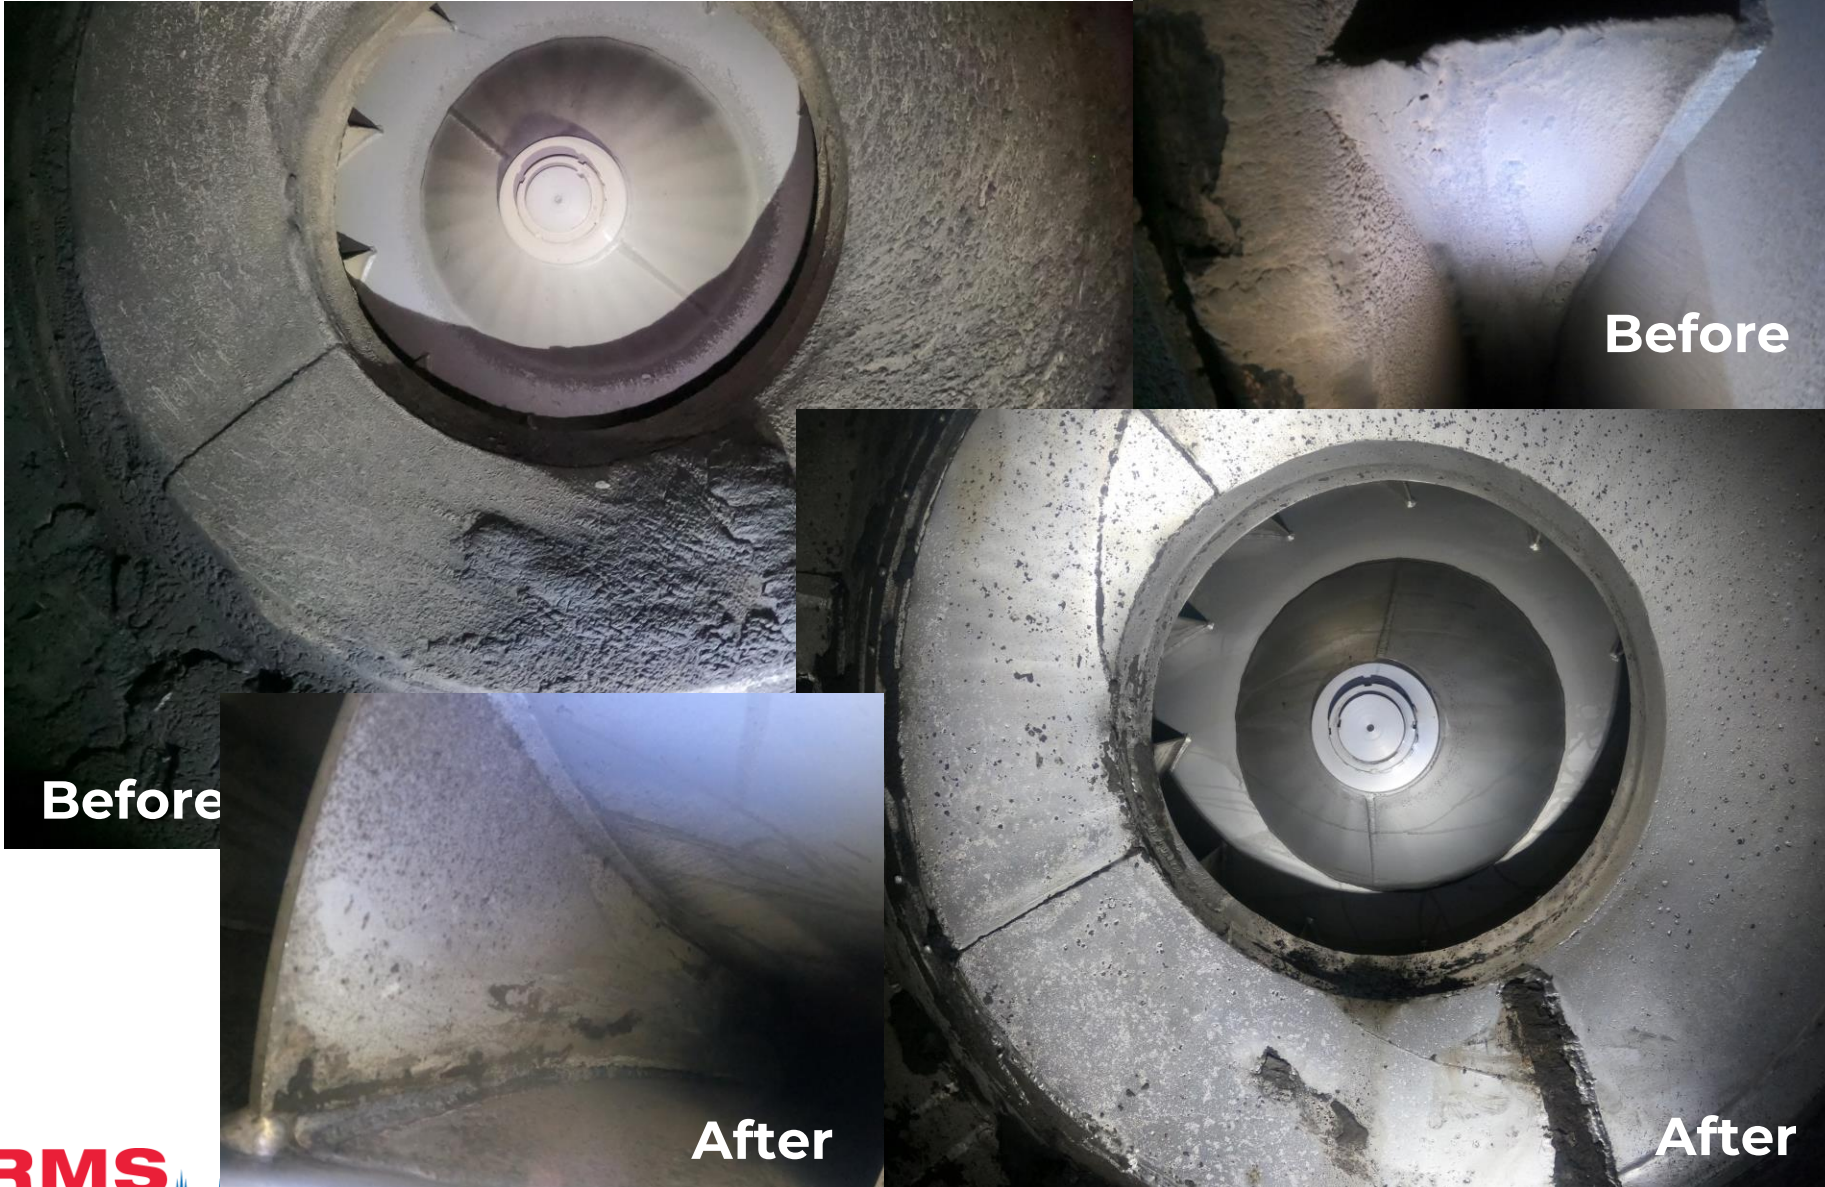
Fan inspection – Before & After Clean

- Fan inspected, found to have heavy dirt deposits on the impellor and casing
- Fan thoroughly cleaned
- **Suspected root cause of unbalance was significant piece of dirt fell off during start-up of the fan.**

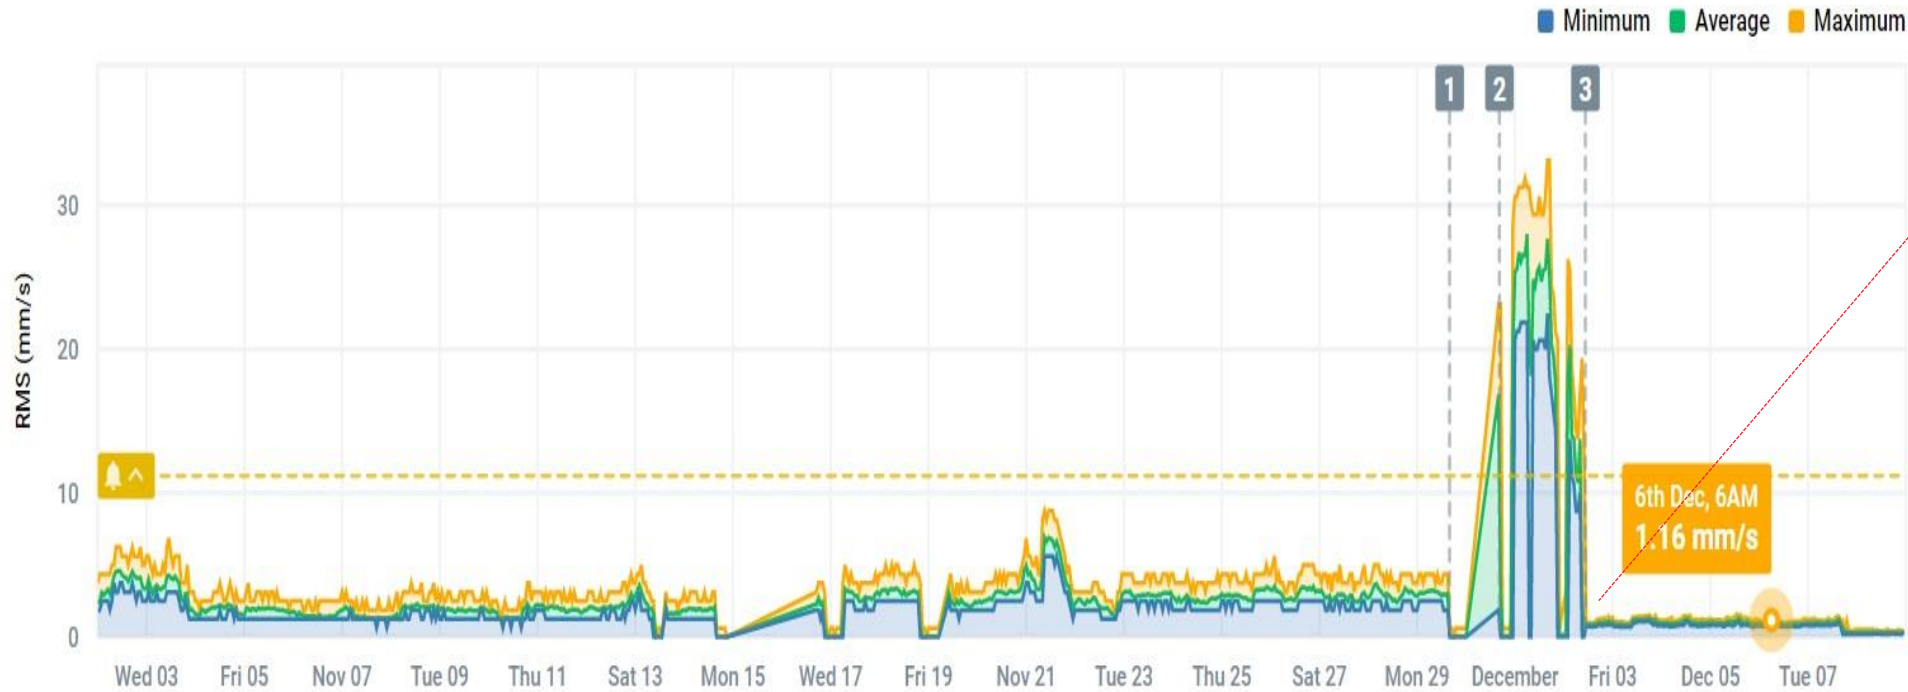
Before and After Fan Clean - Trend Data

- Levels reduced to 1mm/sec after fan clean.
- Investigation planned into why fan had build up of dirt as classed as "Clean Fan"
