Wireless Kappa X Case Study Fan Bearing Defect

CHP Power Plant

Case Example – Fan Bearing Defect

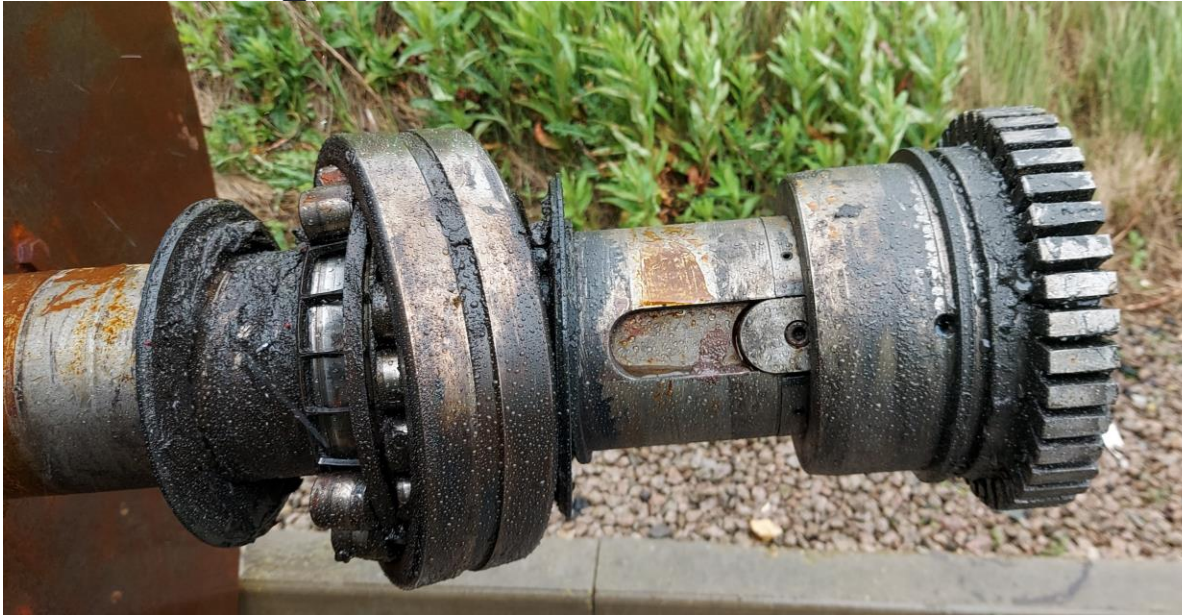
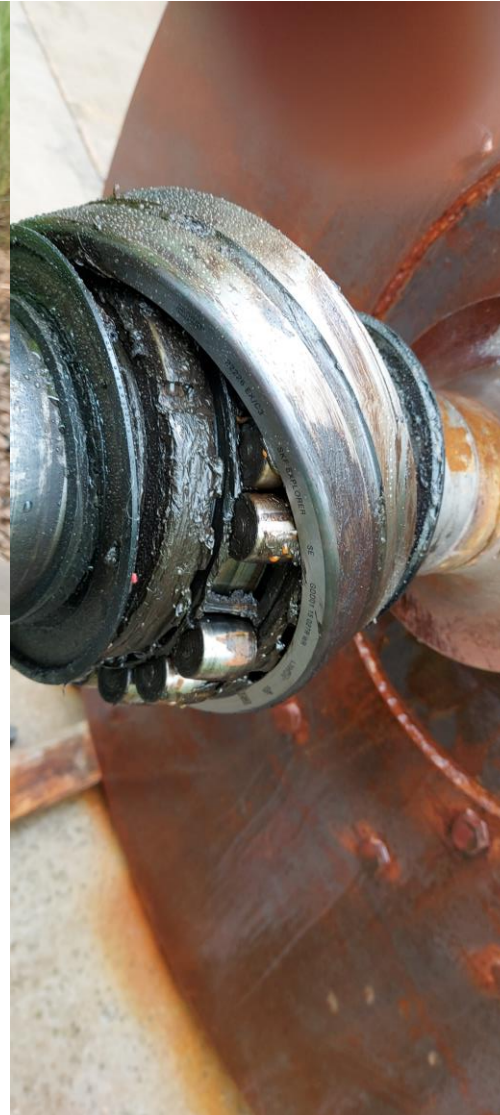
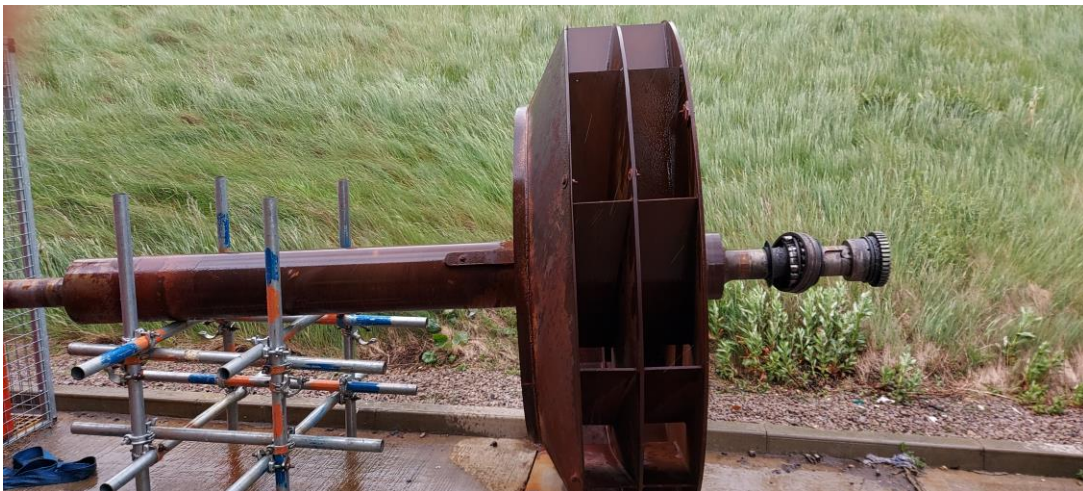
Case Example – Fan Bearing

- Wireless system highlighted bearing defect, early on.
- Recommendation by PDM team was to replace bearing, early when PK-PK levels increased.
- Production overruled and fan was left to run until severe looseness and bearing failure occurred
