RMS

Case Study – Wireless – Kappa X Seal Pump Problem

Petrochemical Plant

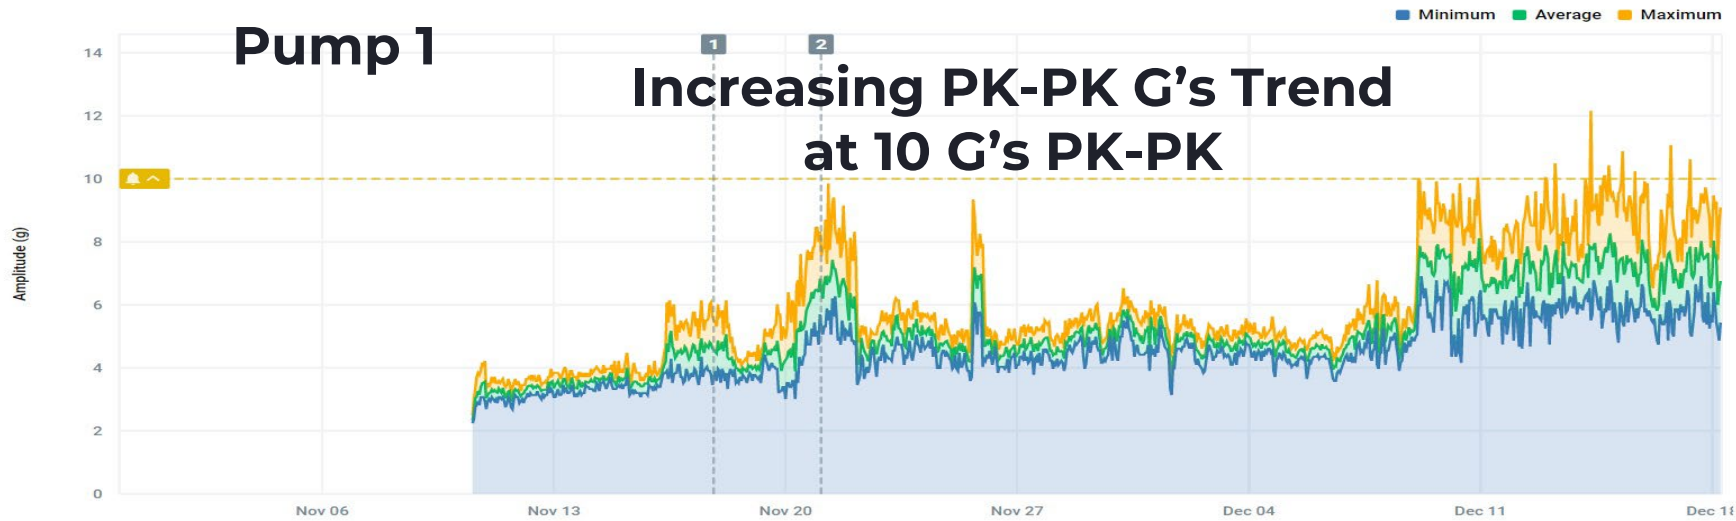
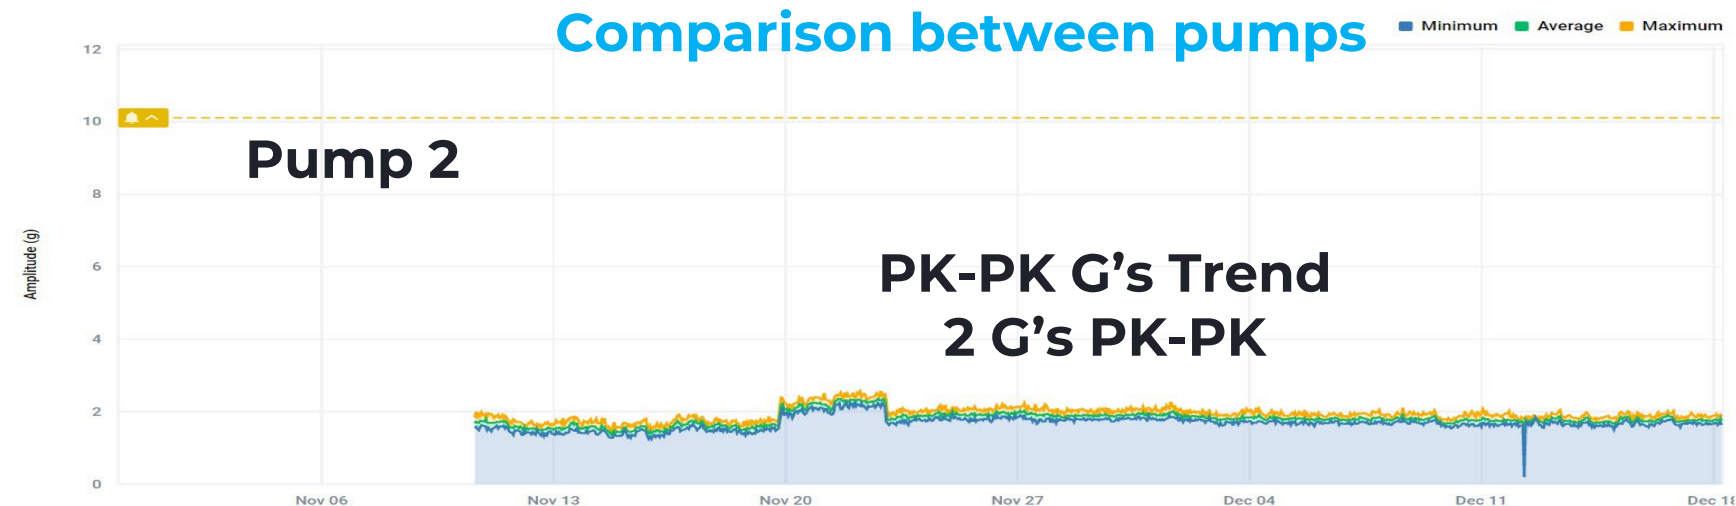
Gear Pump – Vibration Comparison Trends – 1 month

- High G levels on Pump 1 vs Pump 2
- Increasing trend over a month, levels up to 10-15G's PK-PK
- Motor temp steady

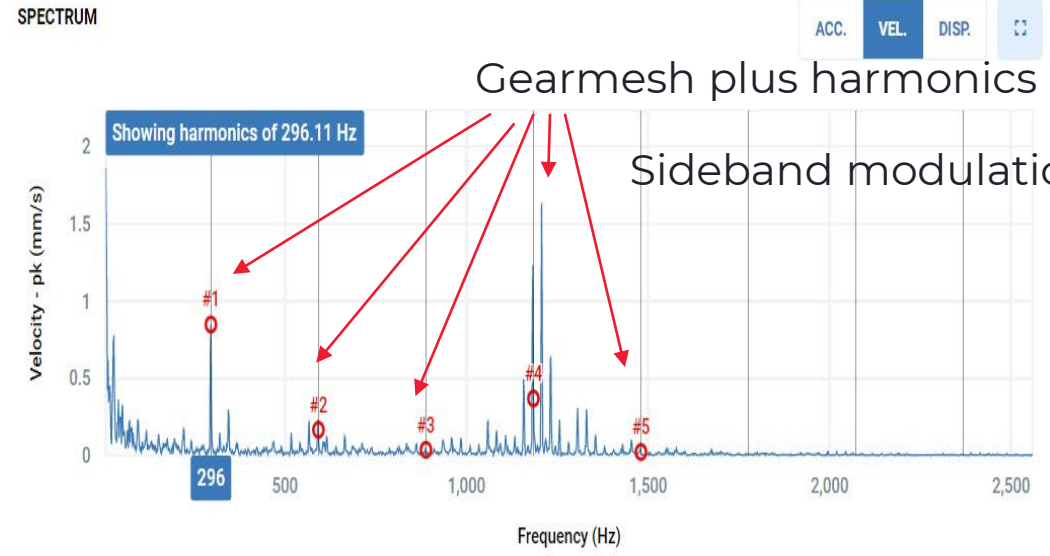
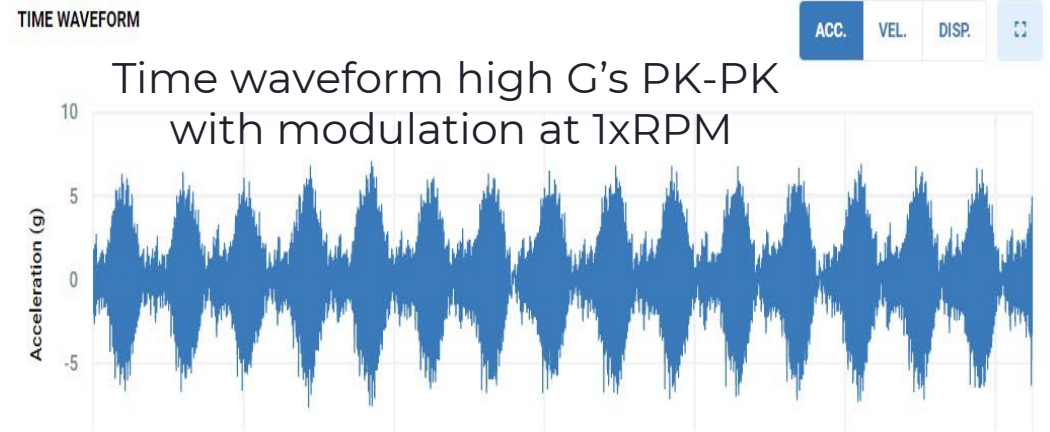
Gear Pump – Wireless Spectral & Waveform Data

TIME	04:21:13 on 30th November	
OA VEL.	4.54 mm/s	0.179 in/s
OA ACC.	2.35 g	907 in/s ²
PK-PK ACC.	14.7 g	5679 in/s ²
CREST FACTOR	2.84 (ratio)	
MAX RPM	1480

- Poor gearmesh suspected due to gearmesh harmonics
- 12 teeth x 1480 RPM / 24.6 Hz = **296Hz gear mesh frequency**
- 1XRPM sidebands / modulation in spectrum and waveform

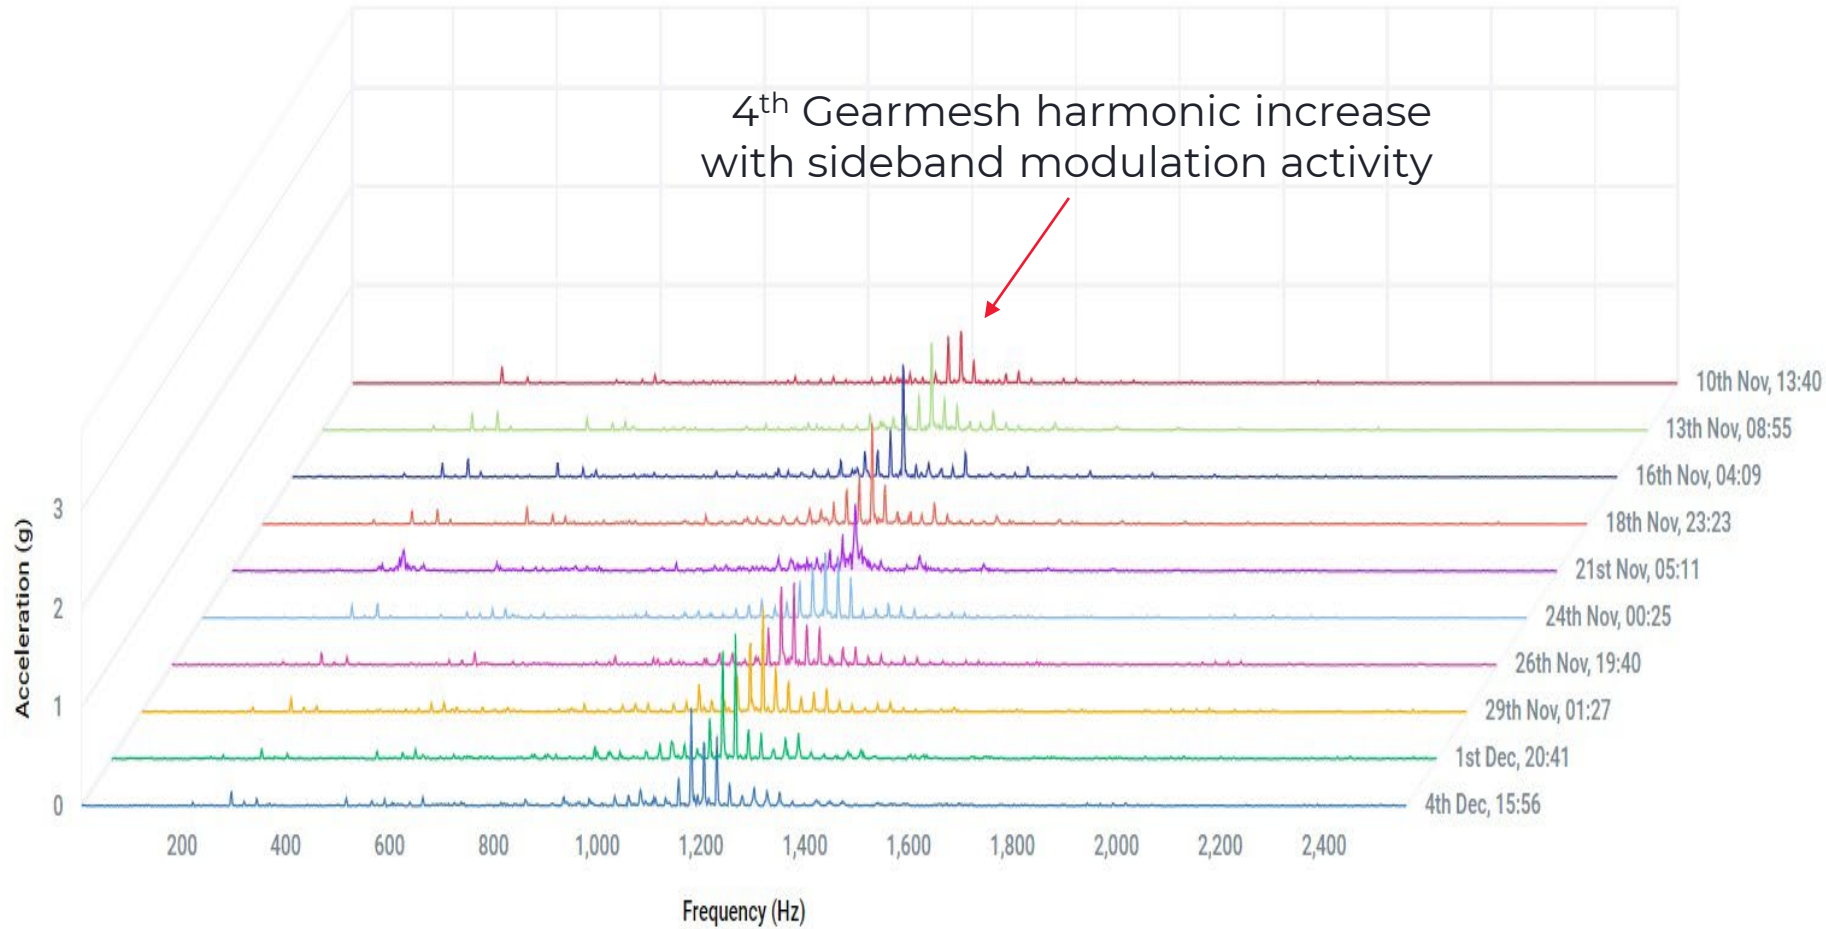
ACCELERATION WATERFALL PLOT

- Increasing gearmesh vibration
- Increase in 1XRPM sideband modulation activity
- Recommendation to pull machine in planned outage for inspection

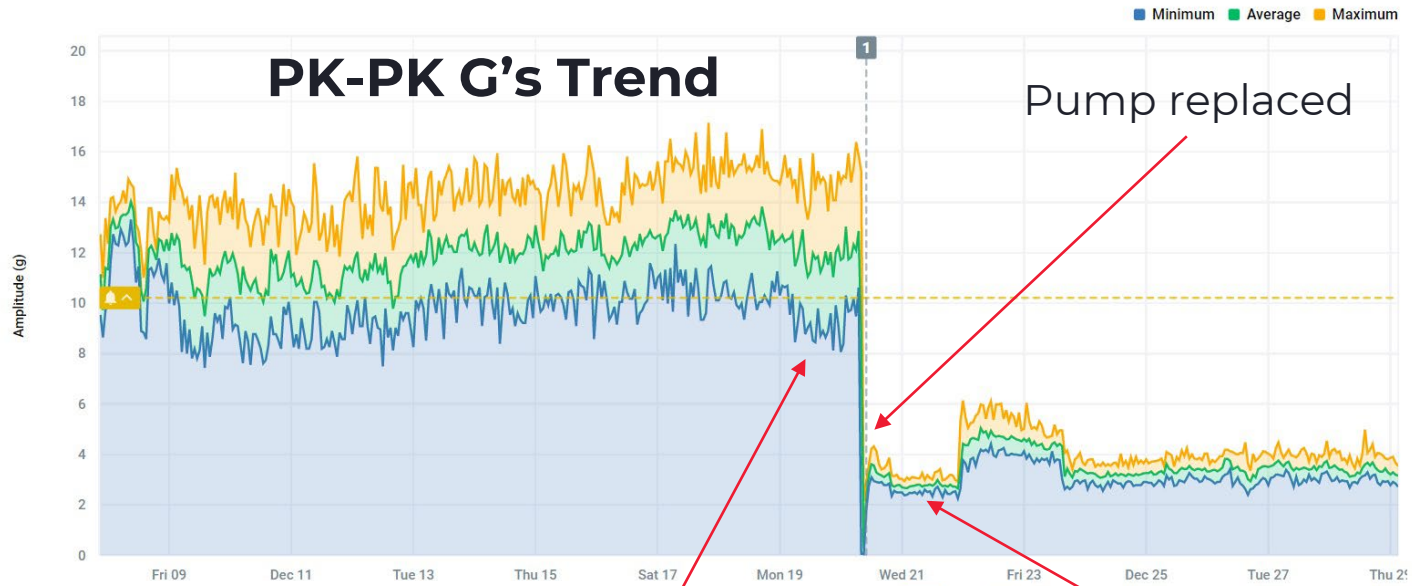
Gear Pump – Before & After

- Pump replaced
- Reduction in vibration levels to 3 G's PK-PK
- New pump shows clean gearmesh

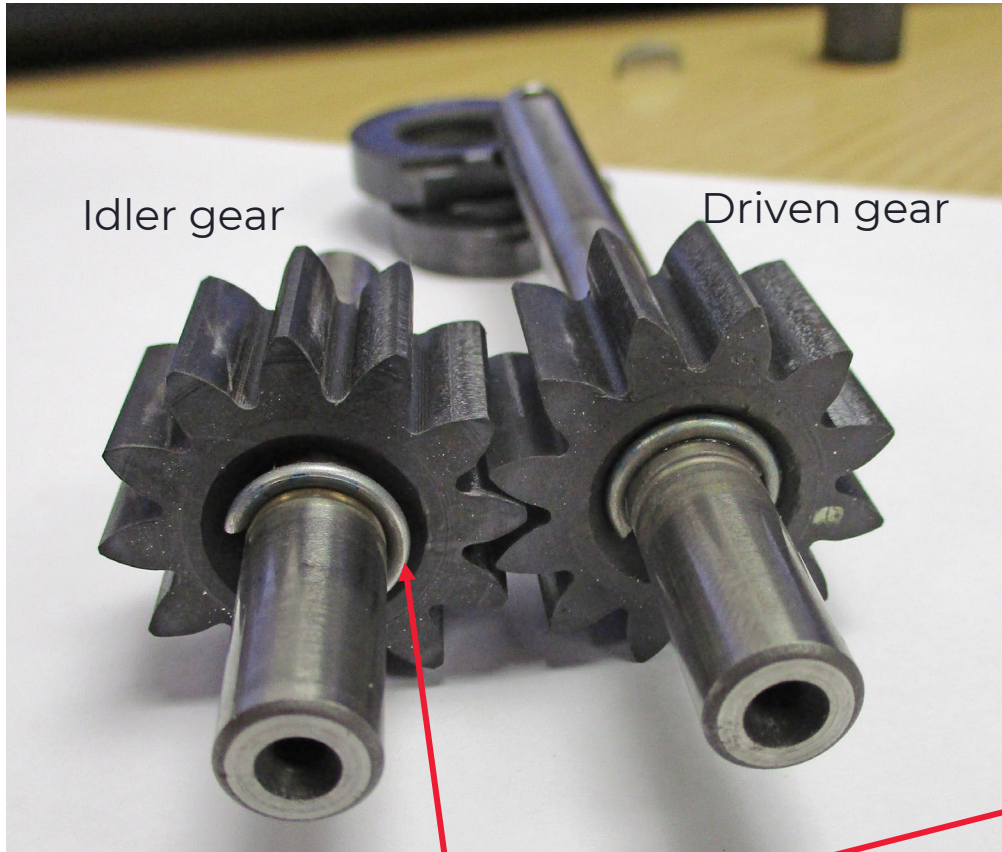
Incorrect circlip placement

- ### Root Cause Analysis
- Incorrect fitment of circlip on idler gear causing poor meshing of gears (Loose gear)
 - Wear on gear key evident due to looseness
 - Occurred during OEM assembly
