RMS  
RELIABILITY MAINTENANCE SOLUTIONS

Case Study

Wireless Vibration

Acid Circ Pump

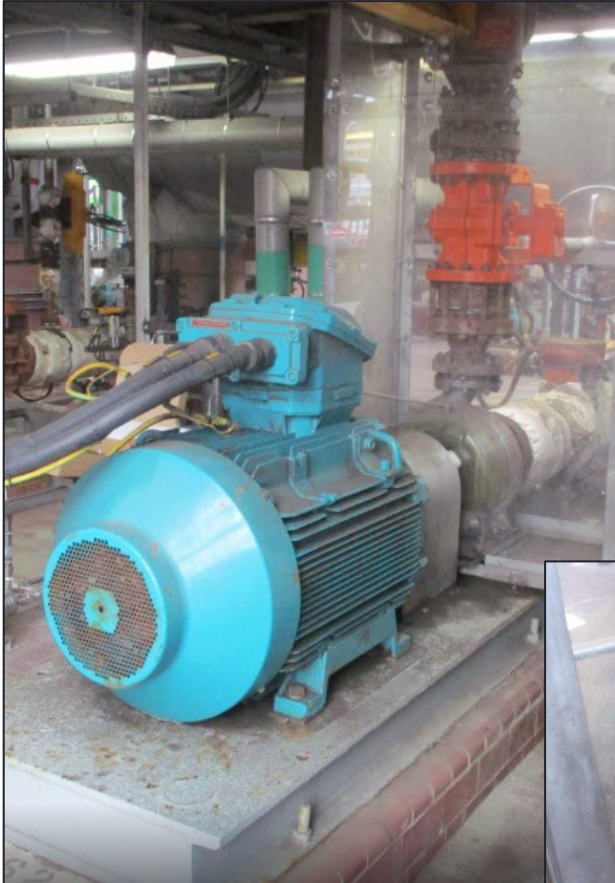
Background Acid Circ Pump

- Acid Circ Pump in ATEX Zoned Area
- 250 kW Centrifugal Pump 2771 RPM
- Aggressive pump application mixing sulphuric and nitric acid within pump.
- Special alloy impellor and bowel
- Known limited lifespan of impellors and bowels due to aggressive environment.
- Kappa X wireless sensor fitted to pump
- Short term tri axial vibration / temp readings every 3 mins Spectrum / Waveform every 24 hours upto 10kHz range.

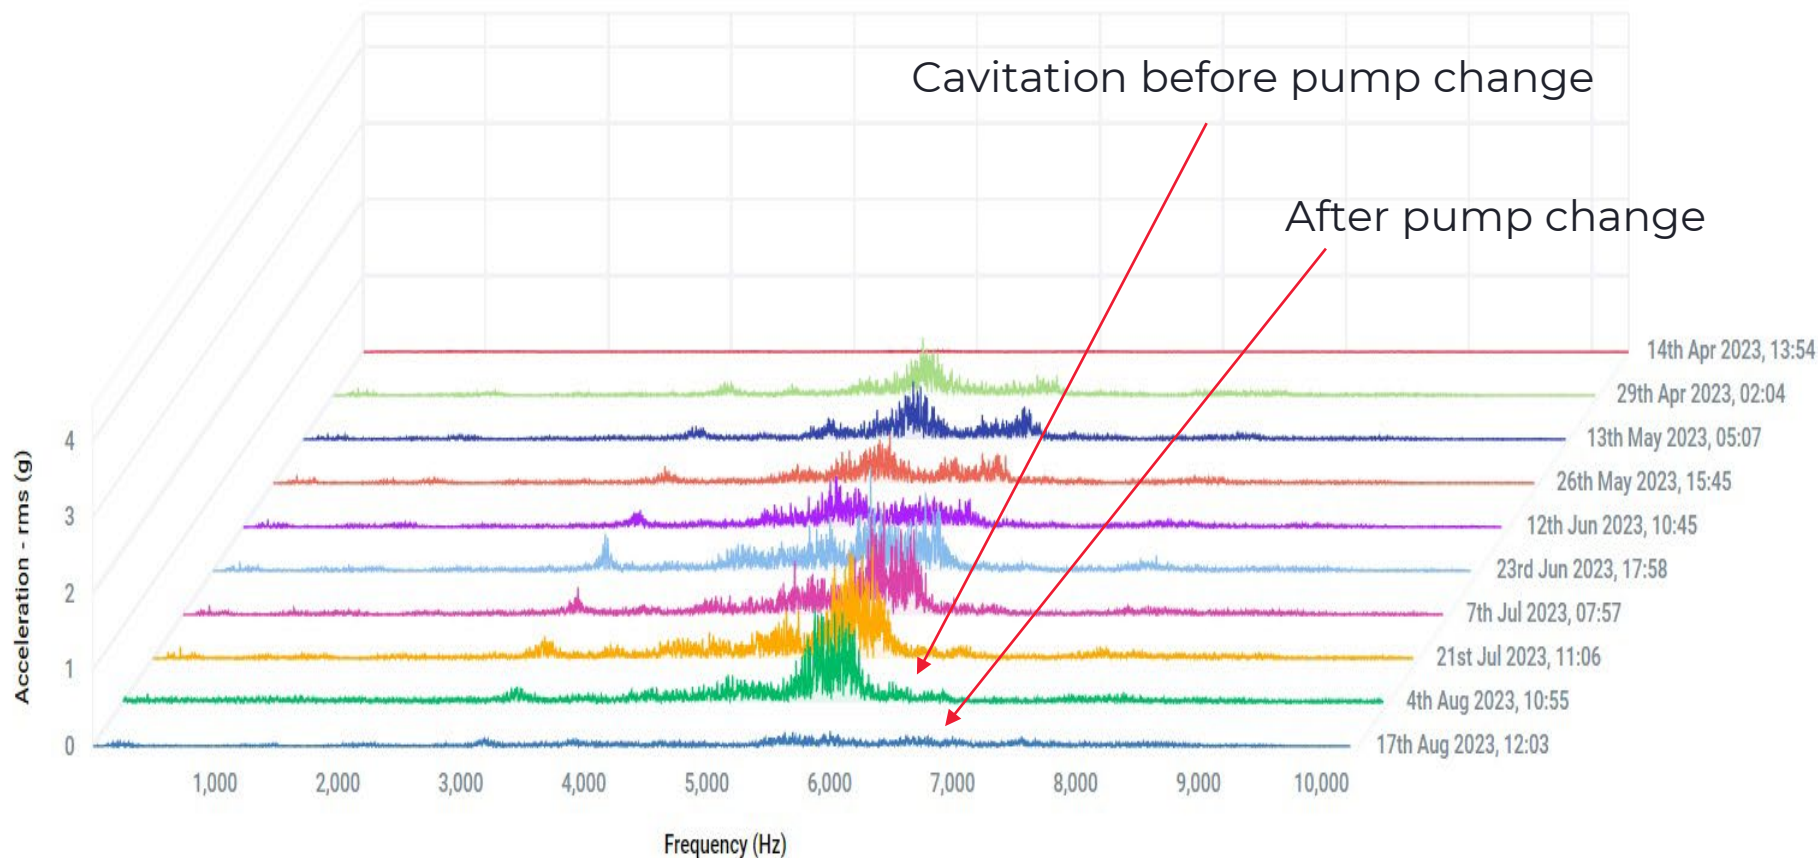
Acid Circ Pump – Spectral Historical Data – Before & After

- Reduction in broadband noise after pump change
- Pump efficiency increased with new pump fitted

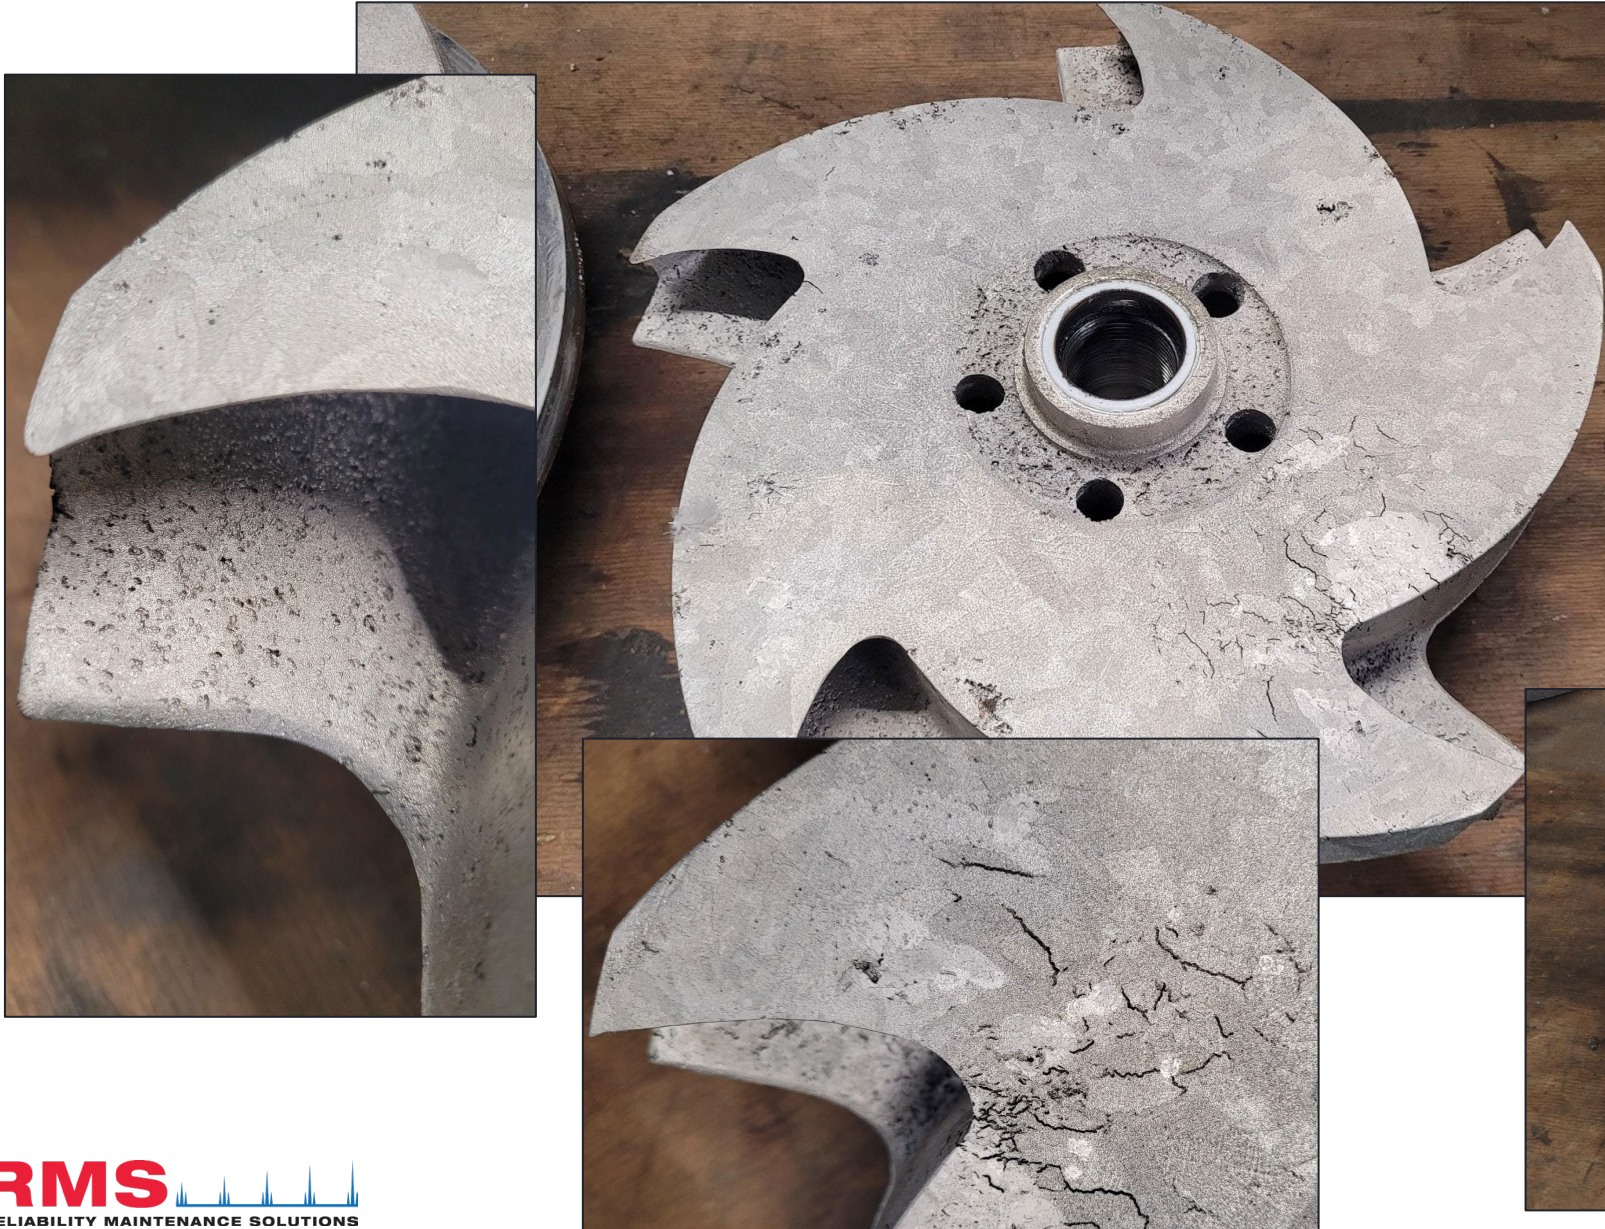
Acid Pump – Root Cause Analysis

- Lack of efficiency due to pump wear on rotating impellor and pump casing
- Root cause of wear is due to aggressive application leading to cavitation within the pump
- High freq wireless vibration can be used to assess internal pump wear in this application.
