Primary Air Fan COGA Unit

Fault Analysis Report

5031-7010 Primary Air Fan (Fan DE Bearing Problem)

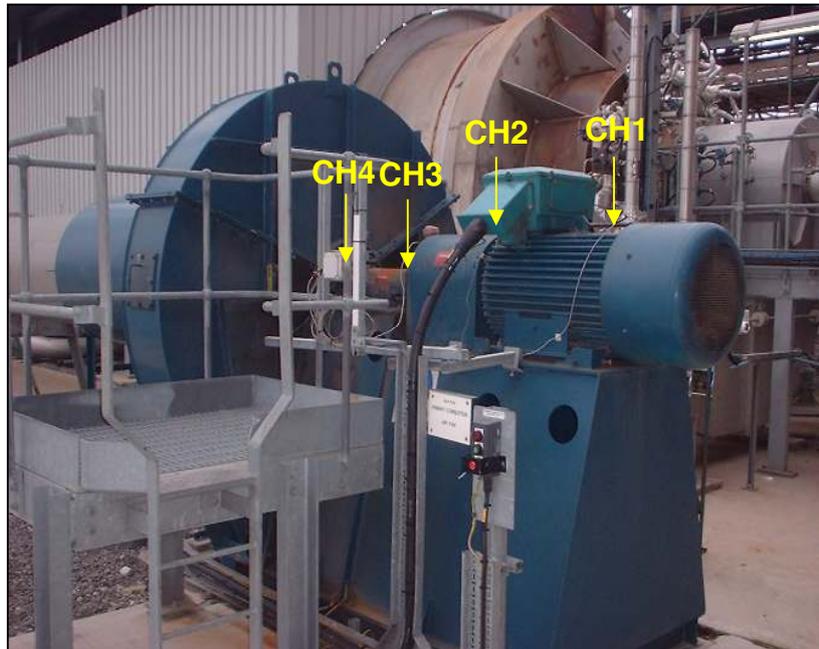
The Primary Air fan is a key part of the COGA Unit; it supplies atmospheric air to the furnace to allow the combustion process to take place. Failure of this asset will result in COGA shutdown, and heavy plant losses.

The fan has four fixed vibration sensors which are wired into the 6500 Online System, the data is sent back to a PC where trending & analysis takes place.
