COGA Unit Flue Gas Recycle Fan 5031-7035

Online Vibration Case Study

5031-7035 Flue Gas Recycle Fan (Online Case Study)

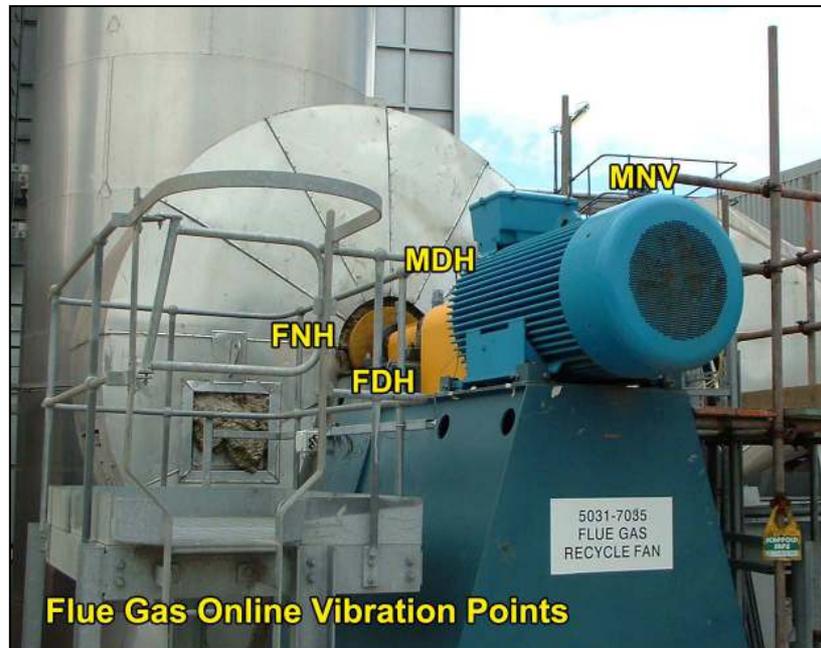
The above Photo illustrates the position of the fixed online vibration sensors that are fitted to the fan and motor (i.e. MNV = Motor Non Drive End Bearing Vertical).

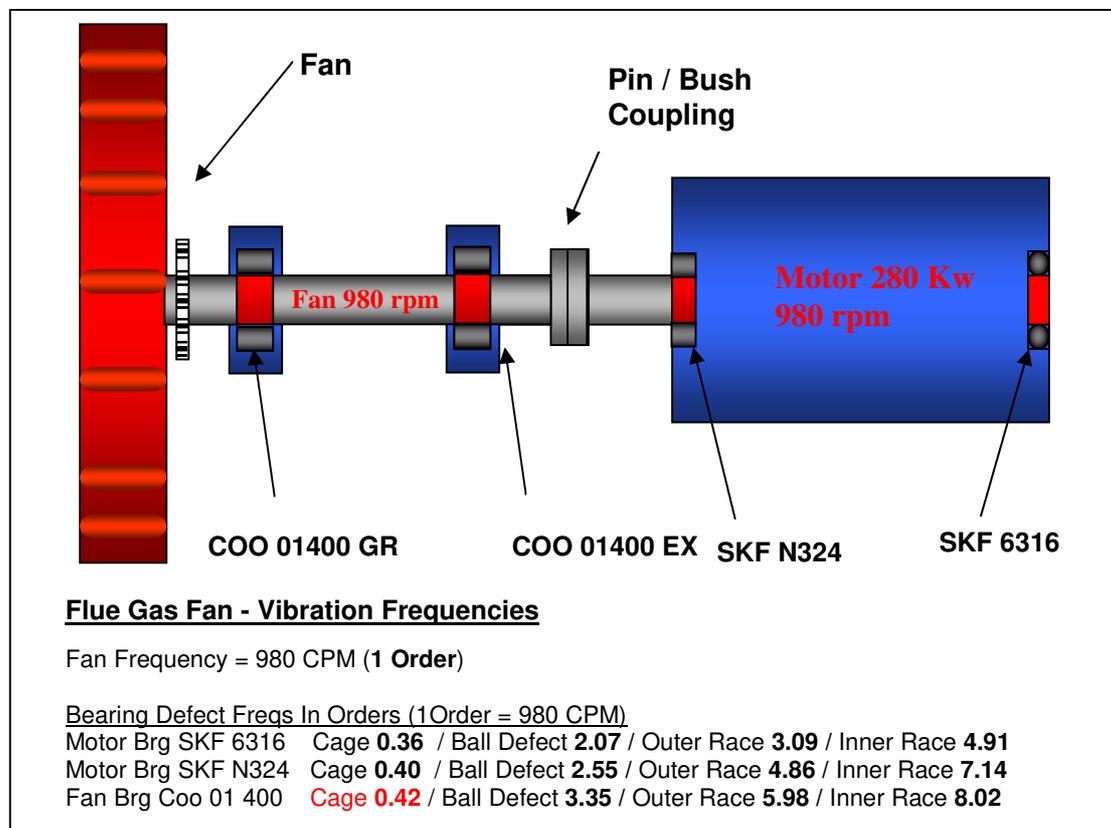
The above diagram shows the configuration of the flue gas fan. The above configurations, speeds, bearing details etc have been entered into the online system to assist in fault diagnostics.
