No.1 DRYER. DRAA

Drying Air Fan

5031-3181

5031-3181 Drying Air Fan (Online Case Study)

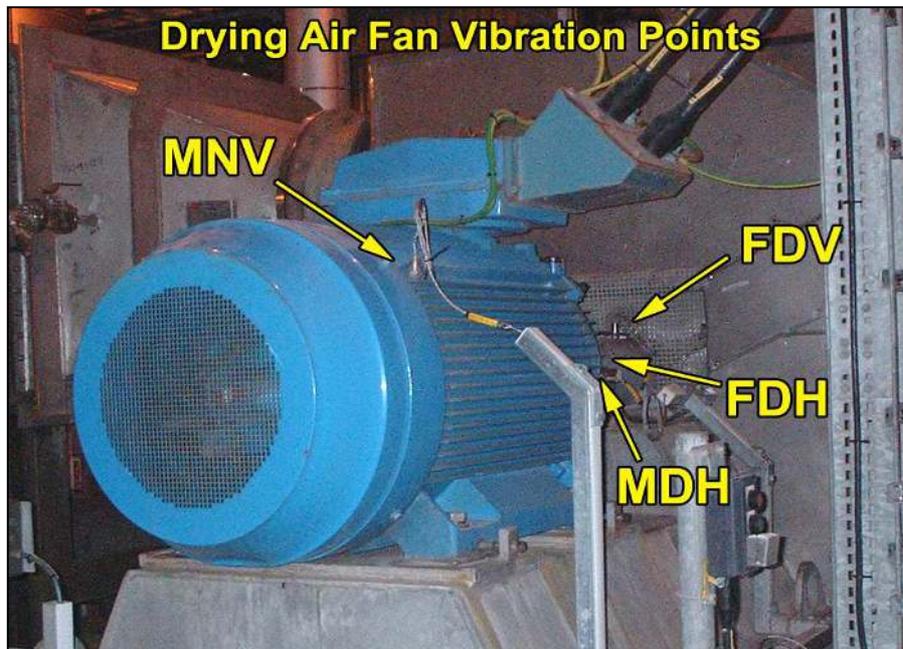
The above Photo illustrates the position of the fixed online vibration sensors that are fitted to the fan and motor (i.e. MNV = Motor Non Drive End Bearing Vertical).

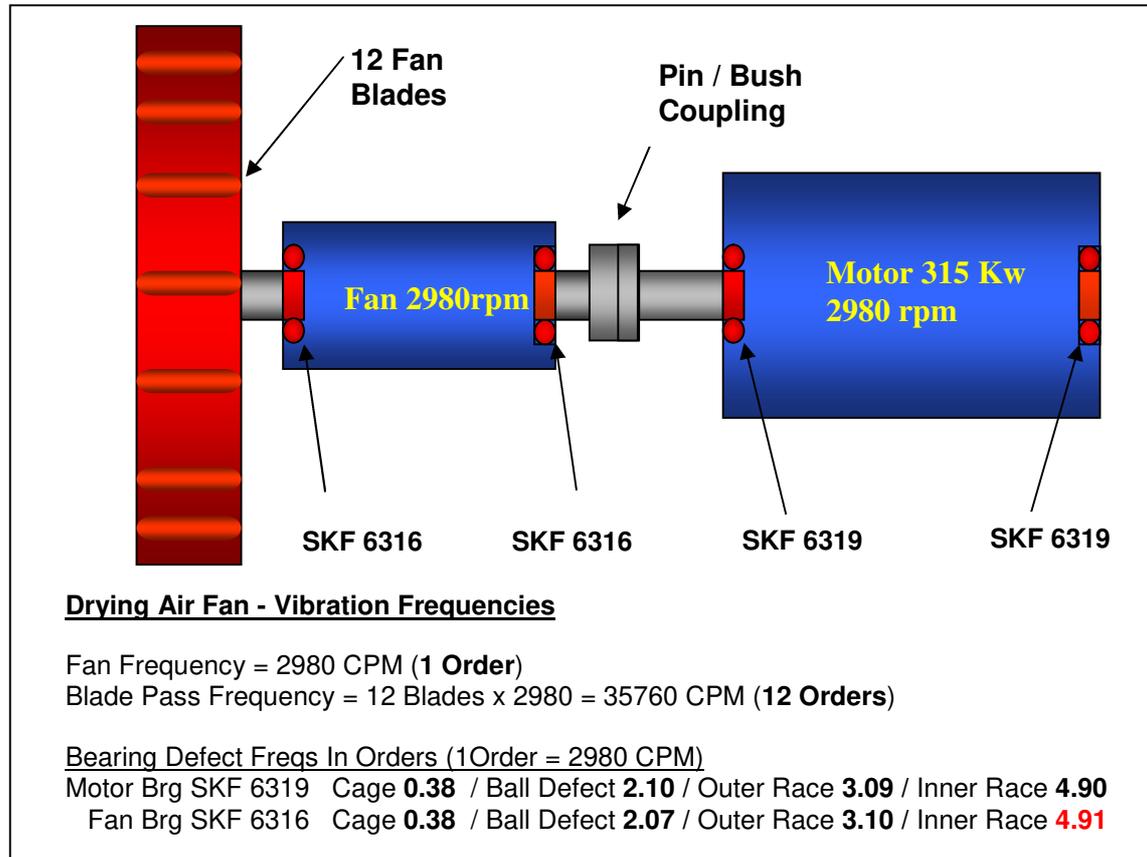
The above diagram shows the configuration of the Drying air fan. The above configurations, speeds, bearing details etc have being entered into the online system to assist in fault diagnostics.

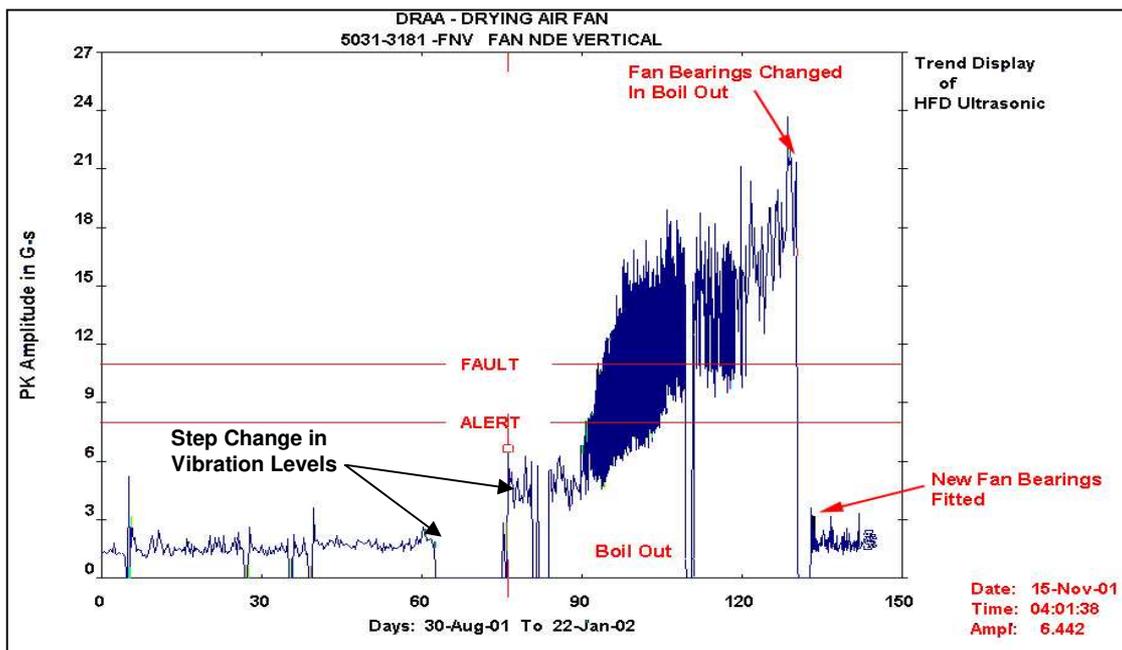
The spectrum above shows multiple harmonics starting from 4.91 orders. This pointed towards a possible bearing defect, all the bearing defect frequencies were overlaid and a match was found with the inner race of the fan bearings (**Skf 6316**). The data indicated that an **inner race defect** was present at the Fan NDE.

After discussions with production and maintenance, it was decided to take advantage of the next boil out and replace the fan bearings within this **planned shutdown**. Boil outs are dictated by production parameters, they are however useful for minor

maintenance work. Carrying out the fan bearing changes at this time incurred no downtime because it was a planned outage.
