Case Study – Vibration Analysis

Hammer Mill – Motor Bearing Damage

Vibration Analysis – Hammer Mill, Motor bearing defect

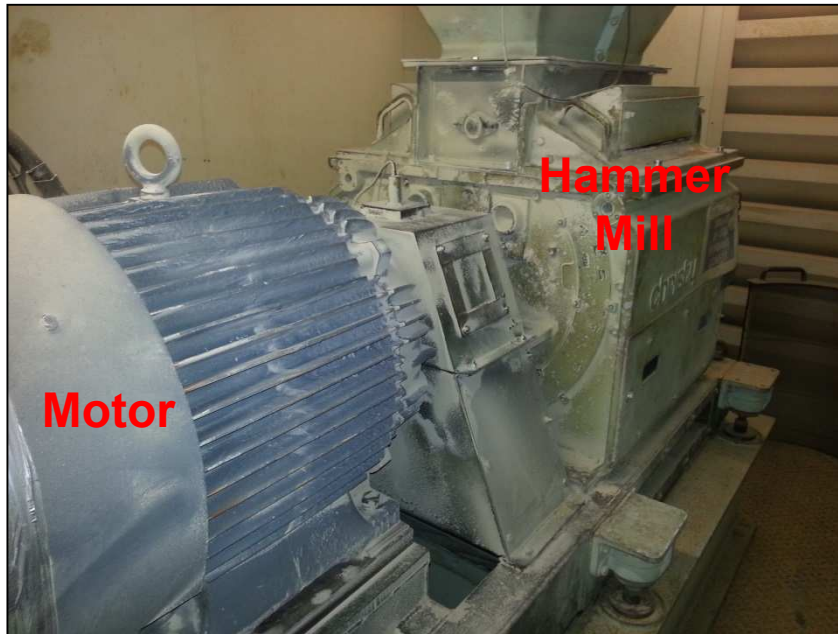
- The Hammer Mill is part of the mashing area on a Bio Ethanol Plant
- It mills wheat in preparation for the Bio-Ethanol Process
- The Motor is inverter driven (Variable Speed)

Monthly Vibration readings are collected and analysed

- Unit was in production from March 2010.
