# Case Study – Wireless - Kappa X Gearbox Brg Defect

Food Sector

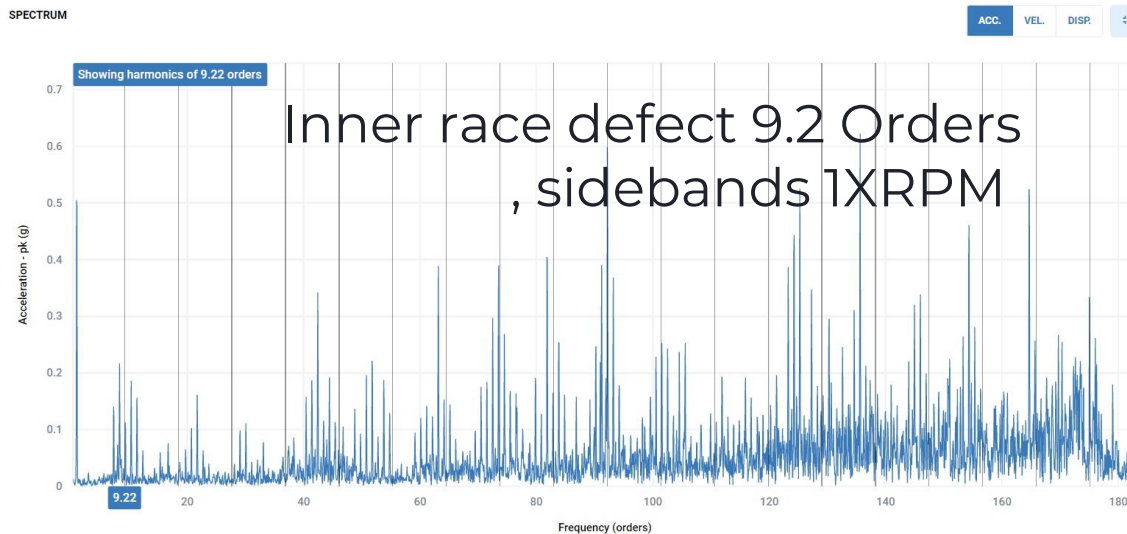
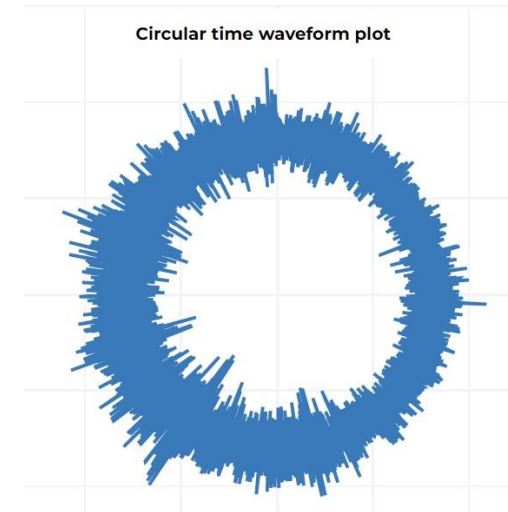
# Gearbox 2 – Spectral Historical Data

- 2.5K degradation waterfall plot
- 10K degradation waterfall plot

Inner race defect gearbox 2
