# Case Study – Wireless - Kappa X Fan Bearing Lubrication Issue

Power Plant - Food Sector

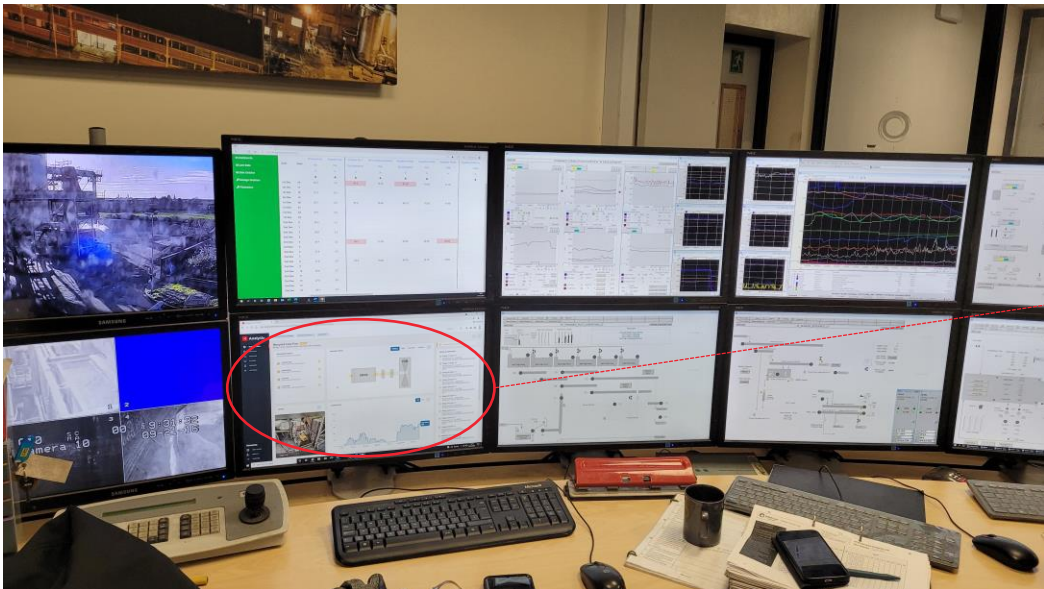
- Critical Gas Fan part of a power plant for a food production factory
- Machine has history of poor reliability. Bearing issues related to lubrication and light loading. Split Bearings fitted.
- Kappa X wireless sensors installed on the fan to monitor condition- 1 min short term trends, with power bands, spec, waveform
- HMI Software setup in control room for site Ops to monitor. Alarms setup based on current fan levels. System will email / text - key personnel when broken.
