Case Study – Wireless - Kappa X Unbalance Problem

Power Plant - Food Sector

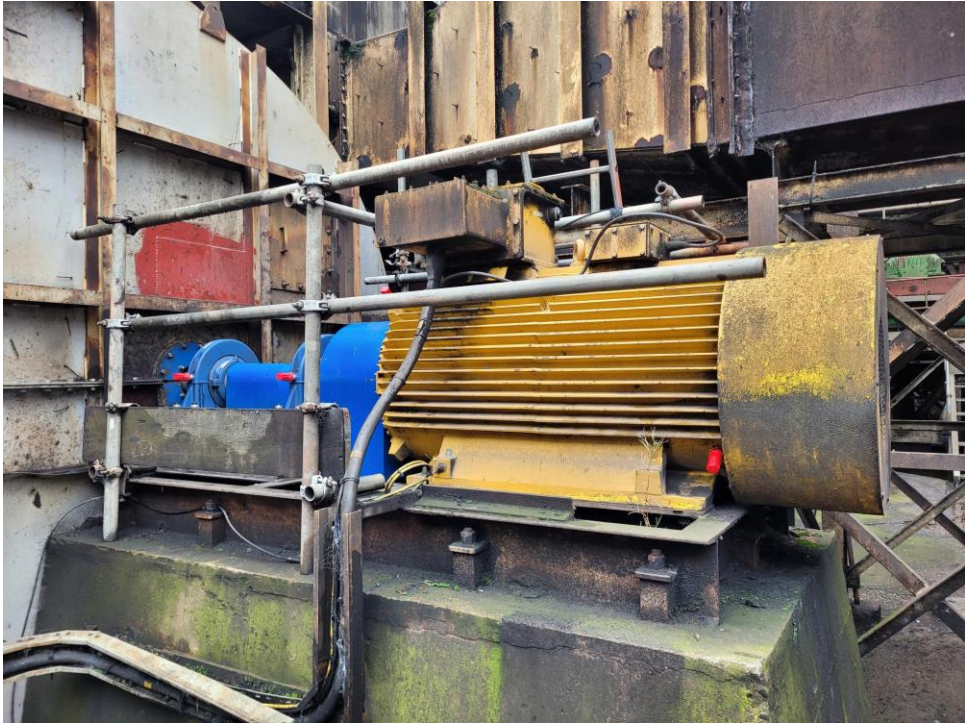
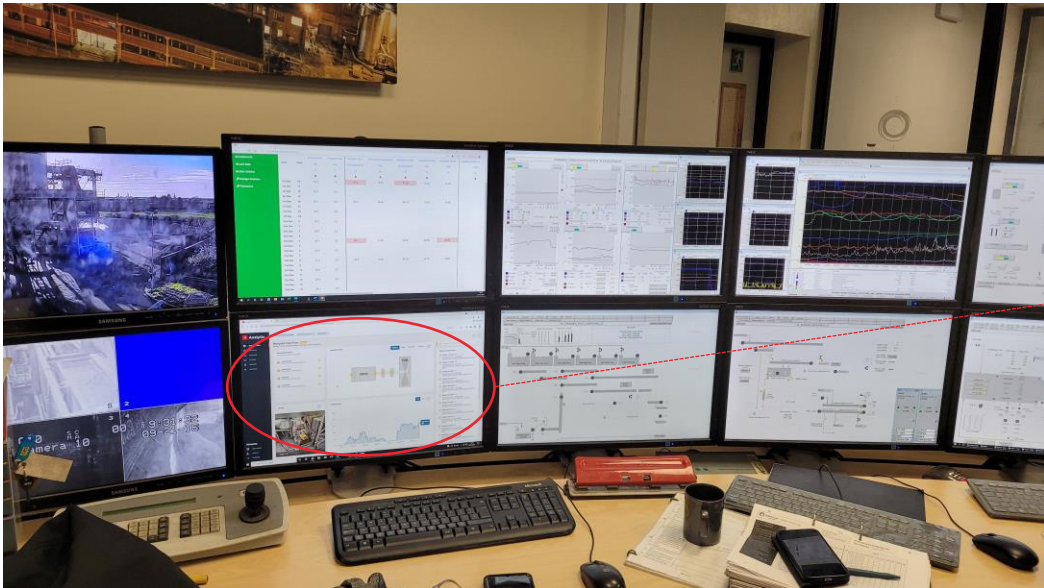
- Critical Gas Fan part of a power plant for a food production factory
- 1485 RPM Direct Drive Fan – 250kW
- Kappa X wireless sensors installed on the fan to monitor condition- 1 min short term trends, with power bands, spec, waveform
- HMI Software setup in control room for site Ops to monitor. Alarms setup based on current fan levels. System will email / text - key personnel when broken.
