Wireless Kappa X Case Study Fan Bearing Defect

CHP Power Plant

Case Example – Fan Bearing Defect

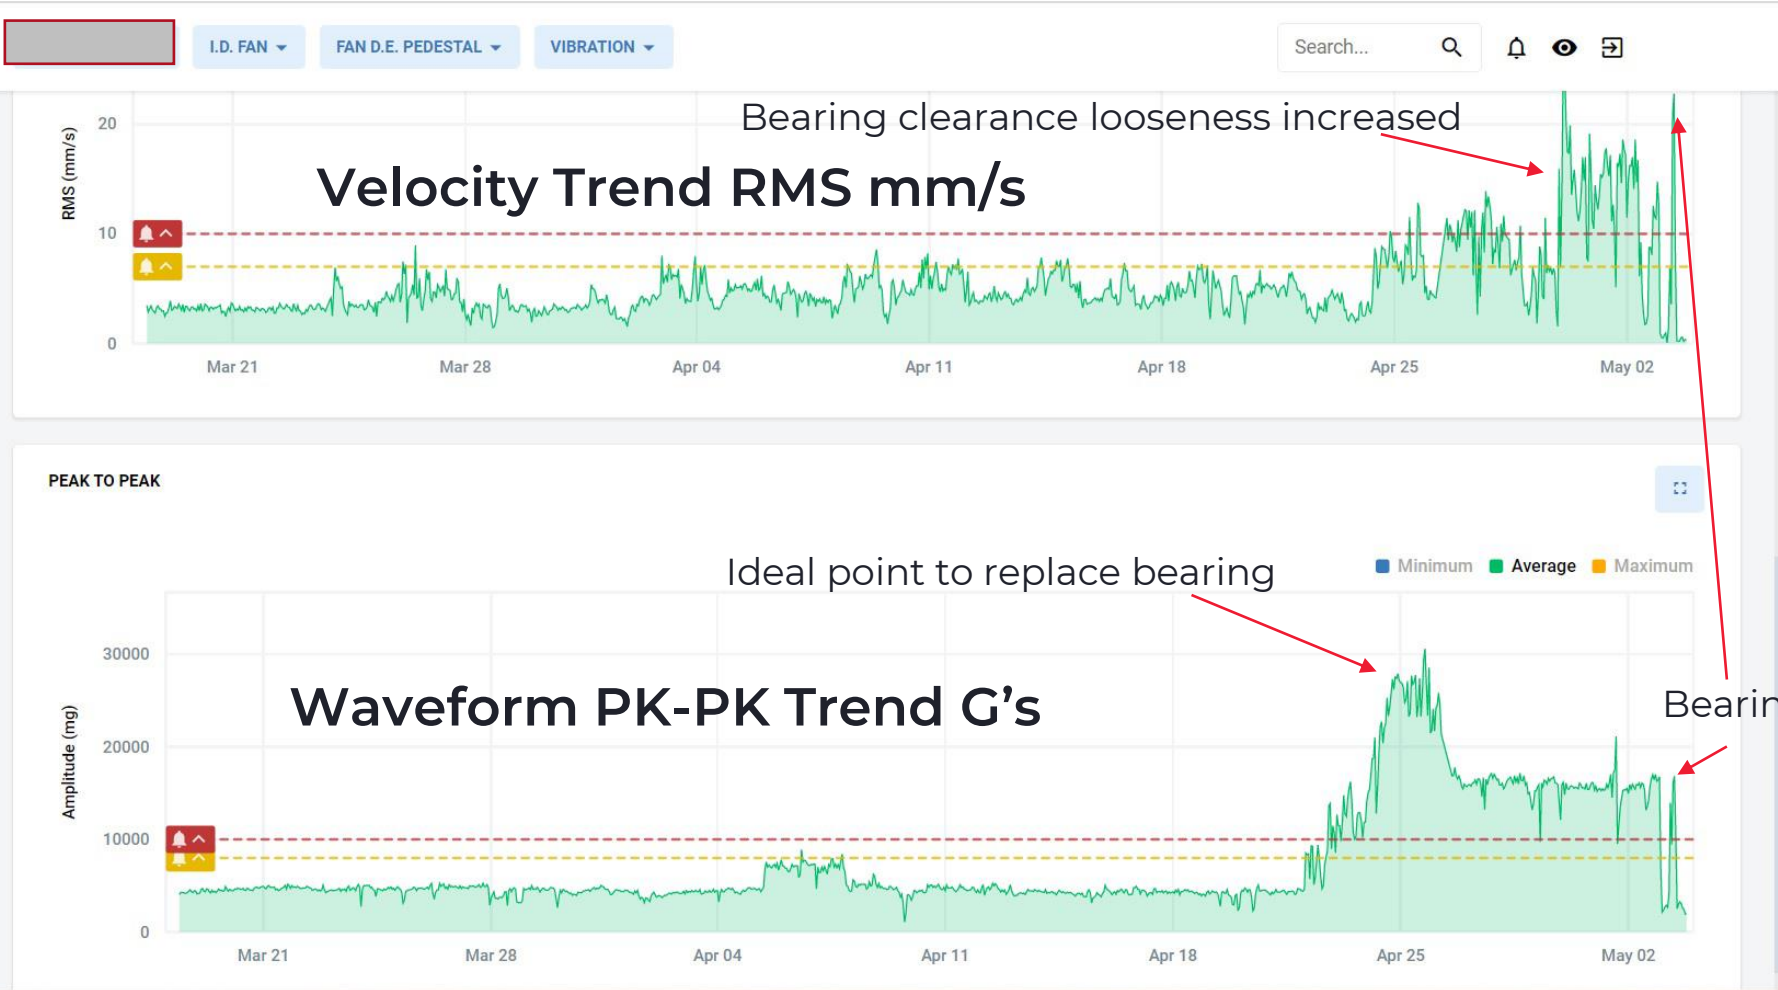
- Wireless system highlighted bearing defect, early on.
- Recommendation by PDM team was to replace bearing, early when PK-PK levels increased.
- Production overruled and fan was left to run until severe looseness and bearing failure occurred
