RMS

Case Study – Wireless – Kappa X Seal Pump Problem

Petrochemical Plant

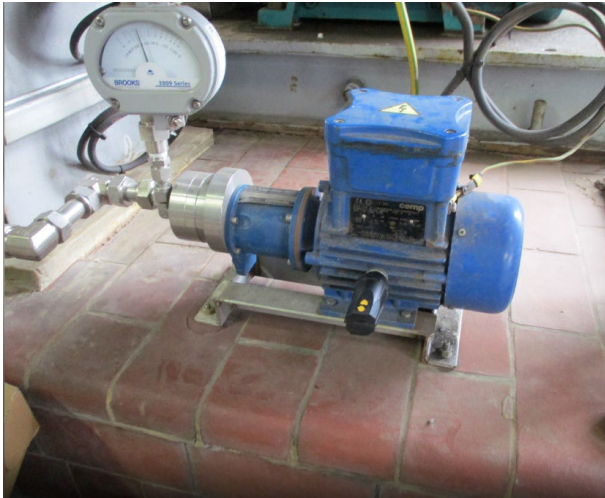
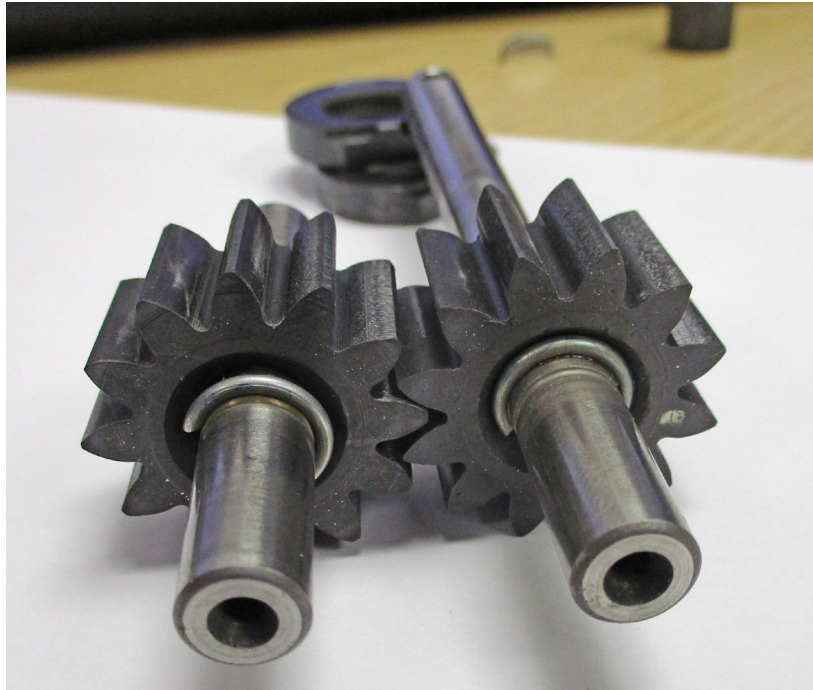
- Critical Seal Flush Pump for larger Acid Circulation Pump in Atex Zoned Area
- 4 kW gear pump 1480 RPM
- 12 teeth on pump gears
- Kappa X wireless sensor fitted to motor
- Short term tri axial readings every 3 mins
Spectrum / Waveform every 24 hours
- New pump was fitted 1 month before wireless kit installed. Historic problems with these pumps due to shaft failures closer monitoring required.

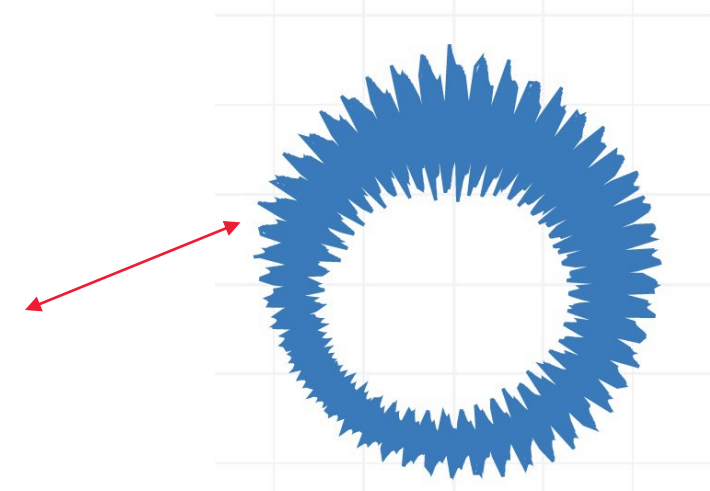
- Poor gearmesh suspected due to gearmesh harmonics
- 12 teeth x 1480 RPM / 24.6 Hz = **296Hz gear mesh frequency**
- 1XRPM sidebands / modulation in spectrum and waveform

Circular time waveform plot autocorrelated
