Monitoring Lubrication Using Multi-Frequency a Sonic/Ultrasonic Sensor

Ray Garvey CSI

This paper describes the use of multi-frequency sonic/ultrasonic measurement as a non-destructive condition monitoring technique to monitor lubrication in greased bearings. Three frequency ranges, 4 kHz, 30 kHz, and 40 kHz, were selected to isolate mechanical faults from friction and lubrication related faults. An experiment was conducted using thirteen grease lubricated conveyor bearings. Measurements were made before and after grease lubrication. Out of thirteen bearings, one was obviously under-lubricated and two others showed some evidence of needing re-lubrication. This multi-frequency sonic/ultrasonic measurement is suggested as a proactive measure intended to eliminate common root causes of failure before costly damage is done.

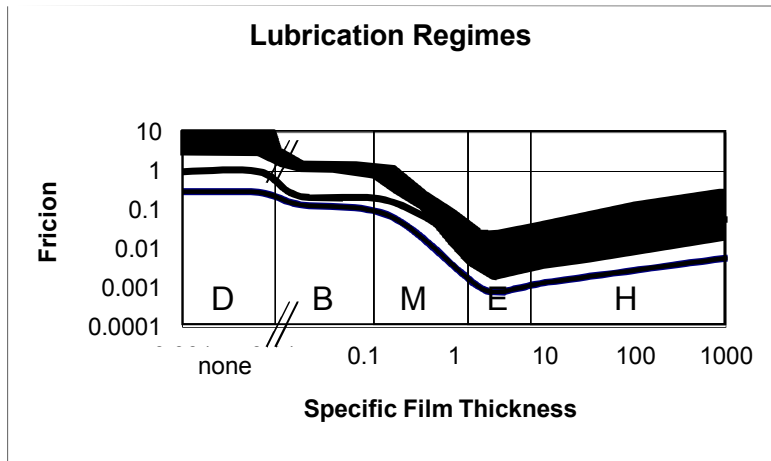
A schematic of lubrication regimes as a function of specific film thickness is shown in Figure 1 below. This figure shows the four lubrication regimes along with the case of no lubricant at all (dry contact). This adds up to five regimes: D, B, M, E, and H. Specific film thickness is defined as the minimum lubricant film thickness divided by the composite surface roughness. This translates into the following approximate actual film thicknesses assuming root mean squared surface roughness of 0.3 micron.

Figure 1. Coefficient of friction as a function of specific film thickness.¹

<u>Regime</u>	<u>Lubricant Thickness</u>
D	Dry contact	0.00 micron (possible 0.01 micron oxide)
B	Boundary Lubrication	0.01 micron
M	Mixed Lubrication	0.01 micron
E	Elastohydrodynamic Lubrication	1 micron
H	Hydrodynamic Lubrication	20 micron

Rolling element bearings, also called anti-friction bearings, are designed to take advantage of the elastohydrodynamic lubrication regime at the roller-to-race interface, and hydrodynamic lubrication regime at the roller-to-cage interface. Lube starvation often causes boundary and mixed instead of desired hydrodynamic and elastohydrodynamic modes. First to go is probably the hydrodynamic lubrication at the roller-to-cage interface. This means high friction at the cage-to-roller interface.

Why is the cage-to-roller typically the first to show high friction when grease quits delivering oil to the bearing? It takes approximately a 20 micron thick oil film to support hydrodynamic lubrication of the roller-to-cage, compared to the 1 micron thick oil film it takes to support elastohydrodynamic lubrication of the roller-to-race. Fortunately the roller-to-cage interface is lightly loaded, so high-friction doesn't mean immediate, high wear. Eventually the boundary lubrication will take its toll on the cage and adhesive wear debris will be released causing secondary damage and accelerated failure progression. If the load and speed are high, the rollers may overheat. Finally, without adequate oil film between the roller and race, friction and torque increase. The increased torque is focused on damaging the surfaces of the roller, race, and cage.

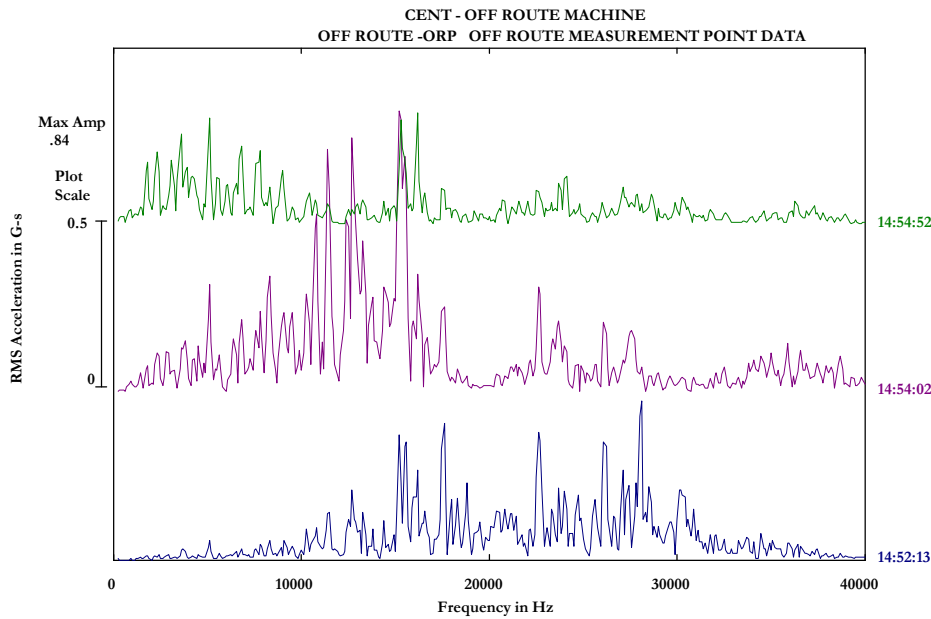
Figure 2. Spectral Data for Steel Balls Impacting on steel plate: 0.5-inch diameter at 14:52:13, 1.0-inch diameter at 14:54:02, and 1.5-inch diameter at 14:54:52.

A study by Robinson² shows differences between mechanical impacting, lubrication faults, and other events using multi-frequency sonic/ultrasonic measurement. Figures 2 and 3 taken from this study show that mechanical impacting has a very different frequency response compared to absence of lubrication.

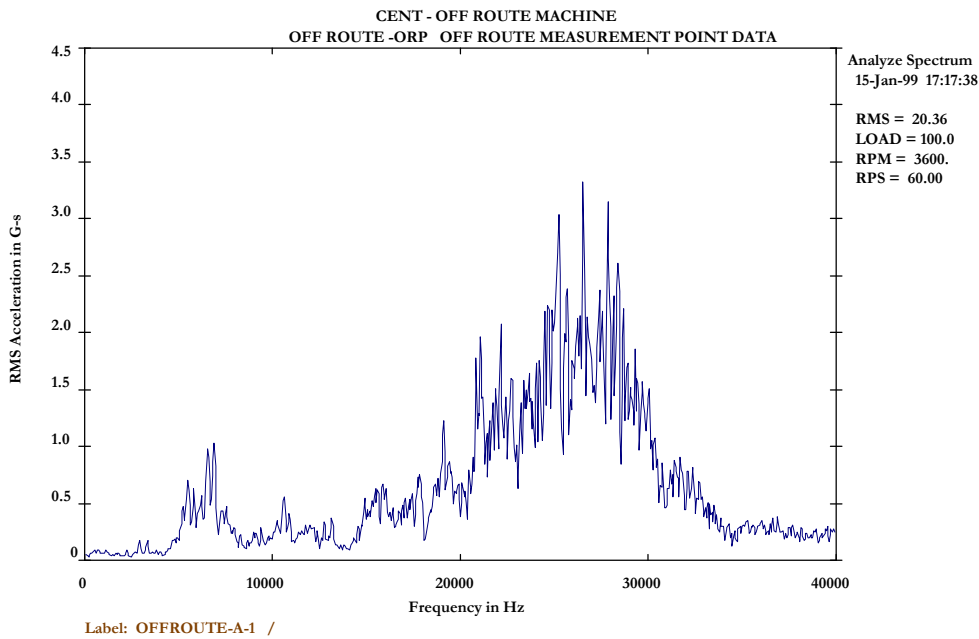
Figure 3. Spectra from a known defective bearing (lacking lubrication) at approximately 4000 RPM.

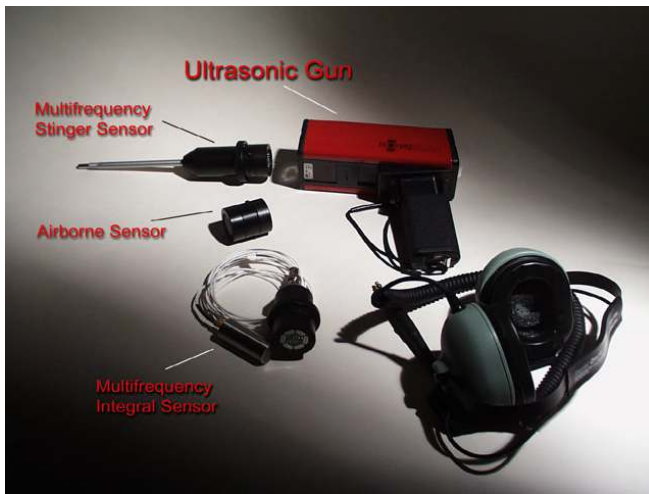
A multi-frequency sonic/ultrasonic/temperature contact measurement device shown in Figure 4 was used to collect data.

Figure 4. Ultrasonic system with multi-frequency sensor.

This device was selected because of its ability to measure decibel energy level in three independent frequency ranges. The low-, mid-, and high-frequency ranges are approximately 4-kHz, 30-kHz, and 40-kHz respectively. The sensor has tuned frequency responses in these three ranges, which correspond to common faults. By knowing what fault types show up in which frequency range, you can identify, quantify, and isolate faults. See Figure 5.

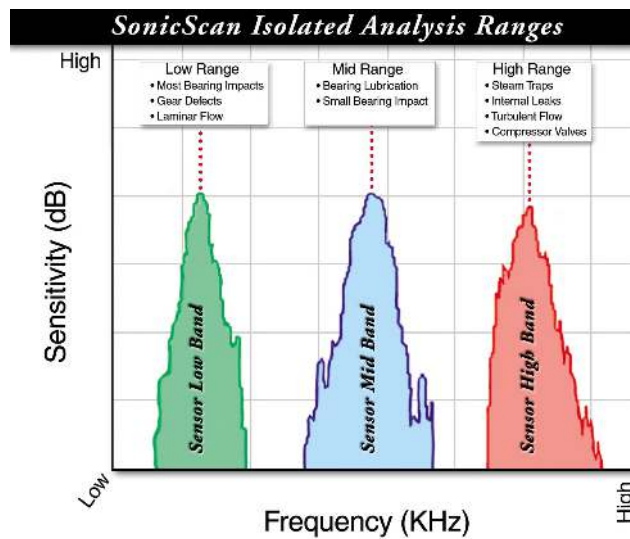
Figure 5. Low-, mid-, and high-frequencies selected for fault isolation.

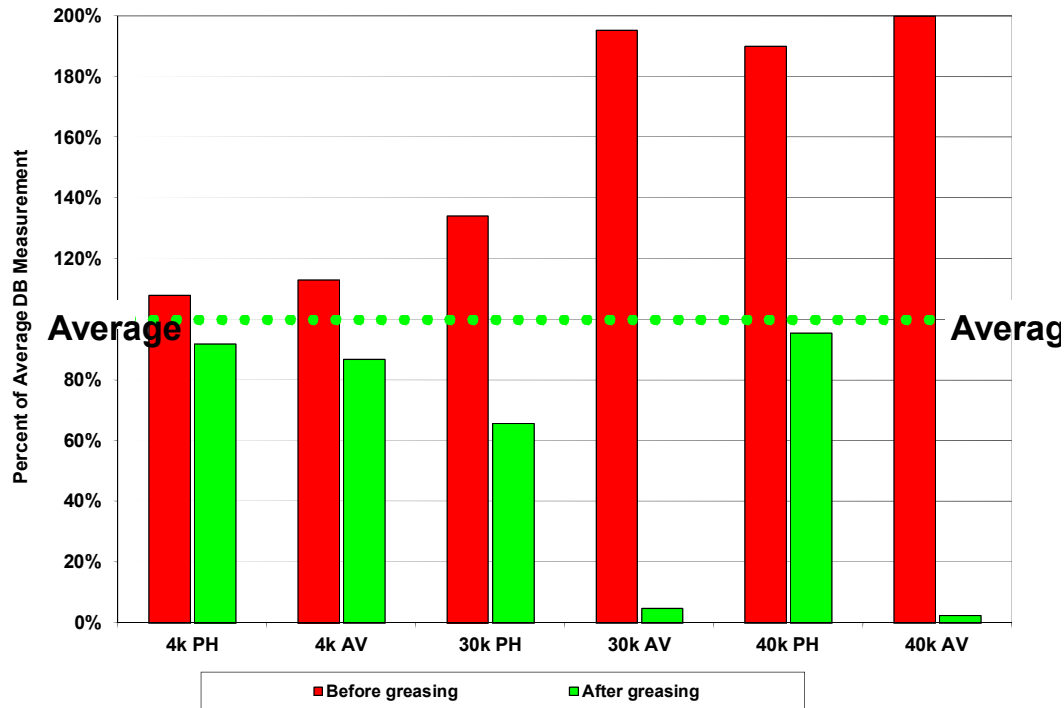
Figure 6. Effect of grease added to bearing # 11.

You can see from Figure 6 how dramatic the change in both the “30k AV” and “40k AV” measurements are for bearing #11. The “30k PH” and “40k PH” are also very revealing. The smallest changes are observable in the “4k PH” and “4k AV” measurements.

Bearing # 11 reported the most extreme values in most categories before greasing. It is also the one that was hardest to reach. A ladder and long reach were needed to collect these data. A ladder and long reach were also required to grease bearing # 11. This bearing showed very high values before greasing and showed better than average values after greasing. See Table 2.

Bearing	Test	4k PH	4k AV	30k PH	30k AV	40k PH	40k AV	Temperature F
11	A	80	56	77	32	71	29	92
	B	80	56	75	30	68	28	92
	C	77	52	64	20	58	14	92
	D	68	43	26	0	31	0	90
	E	69	44	44	2	39	0	90
	F	65	39	36	0	29	0	90
